| <b>MATRIX</b> | Troubleshooting Guide:<br>Quick Keys | |
| Prepared by:<br>Emilie McWilliams,<br>Allan Orlofske, Whitney Wells | Date Prepared:<br>3/1/2018 | Models Affected:<br>Matrix Retail ascent trainers,<br>ellipticals, bikes, and treadmills |

Use this guide for help troubleshooting when the incline, resistance, and/or speed keypad toggles on the hand grips (ascent trainers, bikes, or ellipticals) or console base set (treadmills) do not make the correct adjustments (no response, increases instead of decrease, resistance changes when incline buttons pressed, etc.).

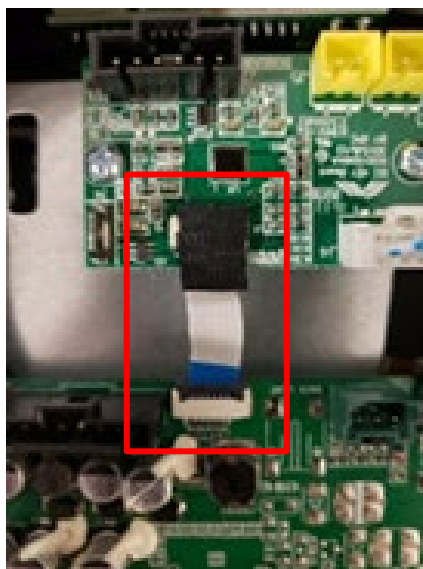
1. XER and XIR consoles only – If the heart rate grips work but the quick key toggles do not respond, check the ribbon that connects the exchange board to the UCB.
  - Make sure that both connections are snug and seated correctly.
  - Reseat the ribbon as necessary. If the tape that secures the cable to the exchange board is missing or loses its adhesive properties, use a small pieces of Mylar tape to replace it.

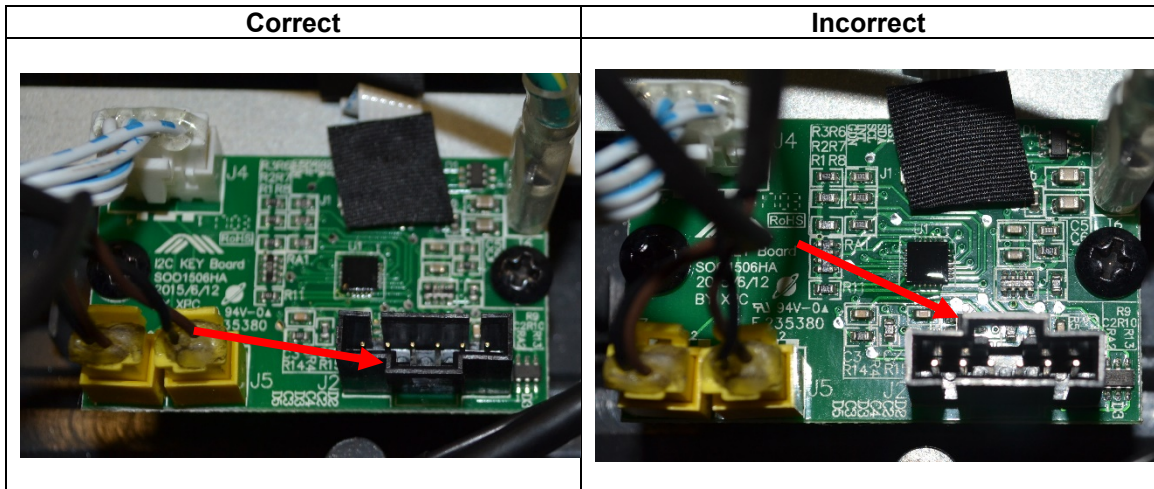
2. XER and XIR consoles only – Look at the exchange board. Verify that the header for the grip wire is attached in the right direction.

**Note:** Due to an issue from January 2017, some A50, E50, TF50, and T50 units with XER and XIR consoles shipped with the grip wire header attached upside down. The symptoms of this issue vary by the model type. If this occurs on an A50 unit, when a resistance arrow is pressed, incline increases instead, and vice versa (on some frames, the controls may not change).

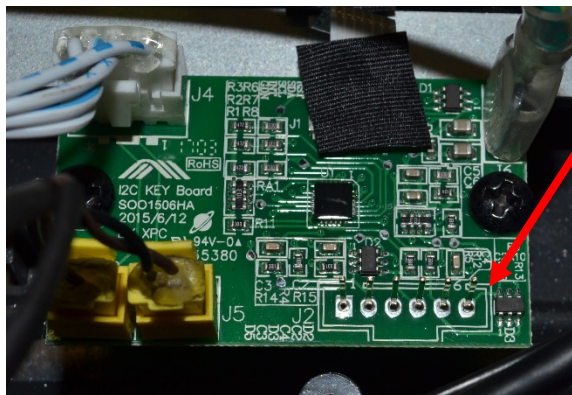
**Tip:** A screen-printed outline on the exchange board indicates the correct orientation of the grip wire header.

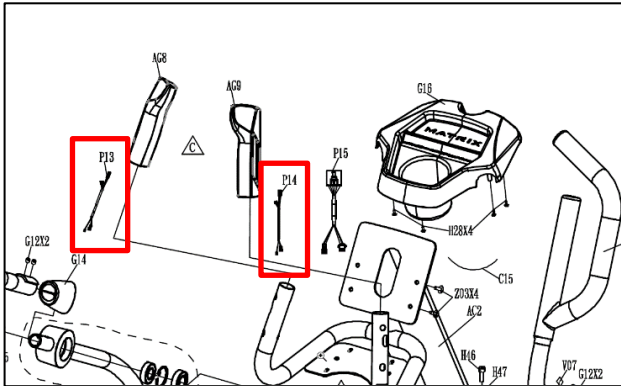
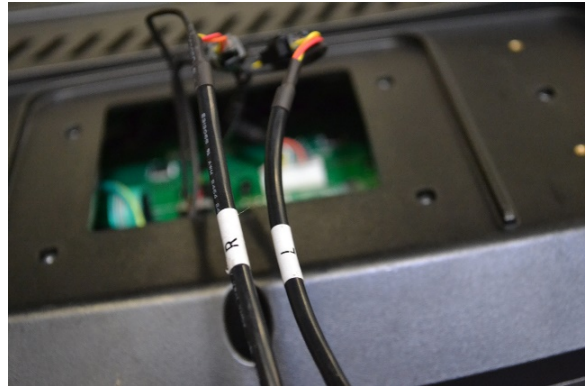
Above: A50 diagram, E30 photo

3. Bikes, ellipticals, and ascent trainers only – If the quick key connecting wires have been replaced, verify that each wire has been routed to the correct grip. If the wires are swapped, the commands will be reversed: For example, when a key for resistance is pressed, incline will change. The wires are labeled “L” (User’s Left) and “R” (User’s Right) to indicate the correct grip.

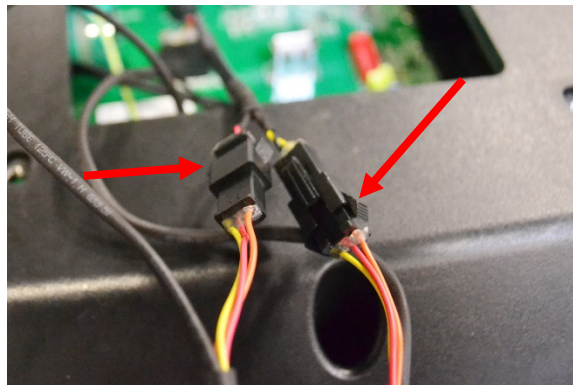
**Note:** It is possible to route these wires to the wrong grip, but it is NOT possible to swap the connections at the wire that connects to the console upper board (P15 in the diagram above). As shown below, one side has a male connector, and the other has a female connector:

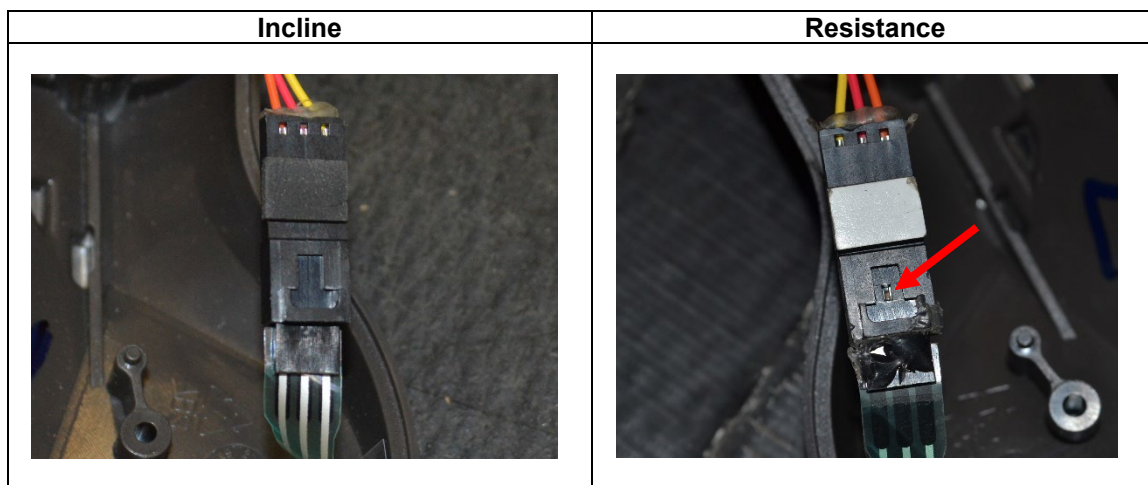
Ascent trainers – Each ribbon connector has one side with three visible metal pins. The incline keypad ribbon plugs into the connector with the metal pin side DOWN, but the resistance keypad ribbon plugs into the connector with the metal pin side UP (one pin will be visible once the resistance ribbon is plugged in). See photos below:

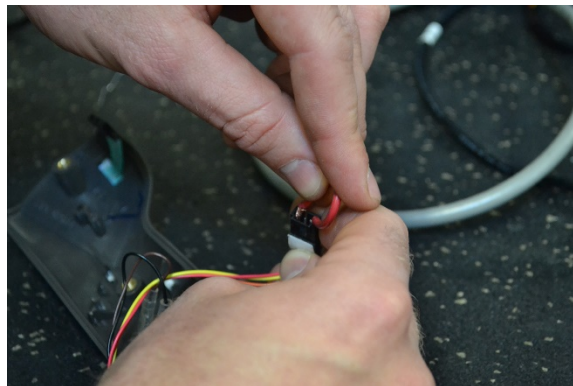
- a. Unplug the keypad wire (on the grip) from the Connecting Wire (Right Grip). Use the piece of metal to touch the two outer pins on the connecting wire's connector (the middle pin is a ground wire)

- If the console beeps and resistance increases or decreases by one level, you have isolated the issue to the keypad. Replace the grip set.
- If the console does **not** beep and resistance does **not** change, continue troubleshooting.

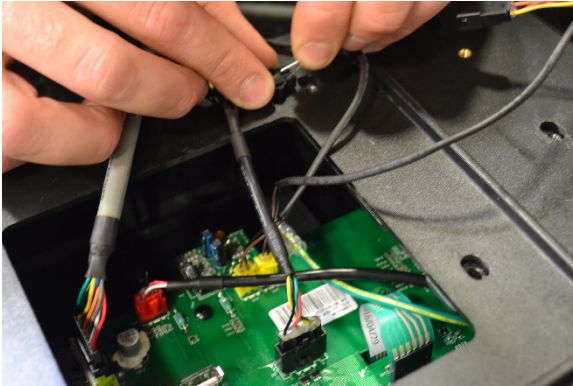
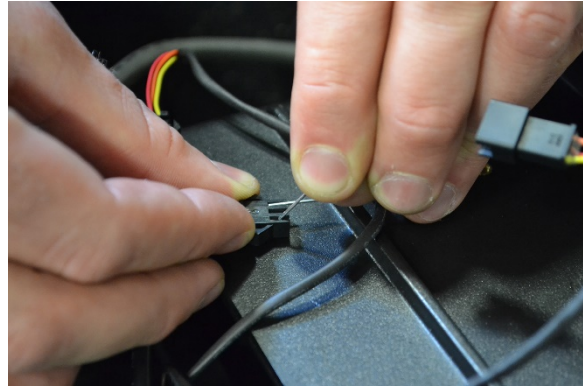
- b. Unplug the Connecting Wire (Right Grip) from the Connecting Wire (Console). Use the metal piece to touch the two pins on the Connecting Wire (Console) plug.

- If the console beeps and resistance increases or decreases by one level, you have isolated the issue to the Connecting Wire (Right Grip). Replace the wire.
- If the console does not beep and resistance does not change, continue troubleshooting.

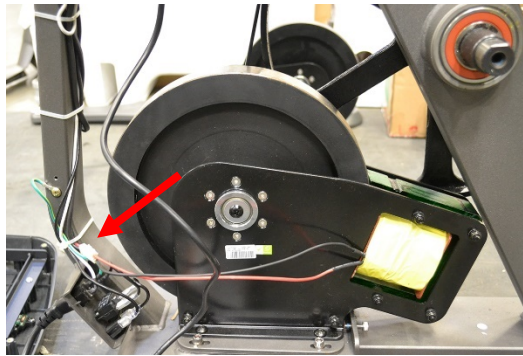
- a. Verify that the red brake wire is plugged into the connecting wire.

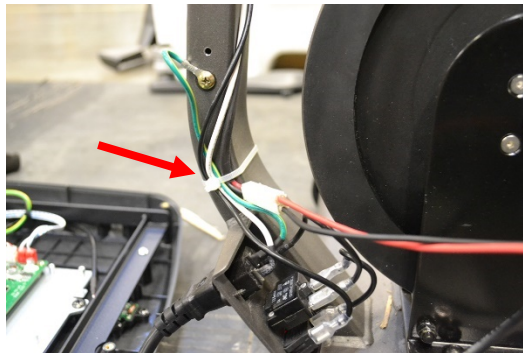
- b. Make sure that the connecting wire is not damaged, particularly where a zip tie secures it to the frame.

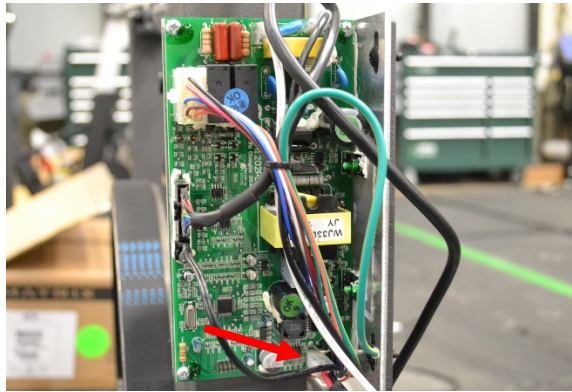
- c. Make sure that the wire is connected to the LCB.
