| MATRIX | | Service Bulletin | |
| | | Matrix 2016 7xi/7xe and T130xi Console Troubleshooting | |
| Effective Date: Dec. 20, 2016 | Models Affected:<br>7xe-05-C (EP620, TM527); 7xi-03-C (EP621, TM528);<br>T130xi (TM541) | Bulletin Num.<br>NB-1701007<br>ver.10 | |

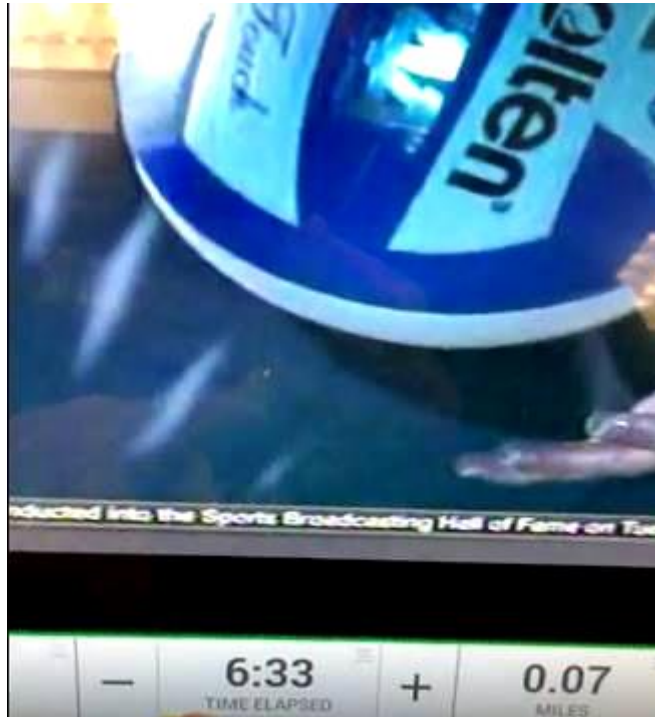
Console is frozen during workout using TV. There is no touch panel reaction, but the keypad is working.

This is a tuner drive software issue.

1. Press "Enter 9 9 1 1 Enter" on the keypad, and then reboot the console. Next, check for software updates and install all updates to latest software version.
2. Run Android Recovery , updates and install software process again.

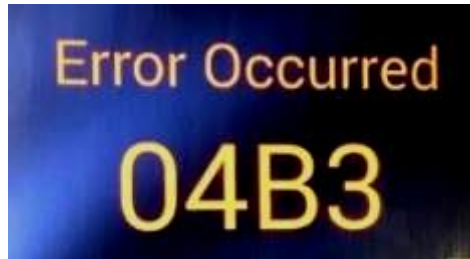
Console shows the 04B3 error code as shown below.

This is a machine setting loss issue.

1. Press “Enter 9 9 1 1 Enter” on the keypad, and then reboot the console. Next, check for software updates and install all updates to latest version.
2. Run Android Recovery , updates and install software process again.

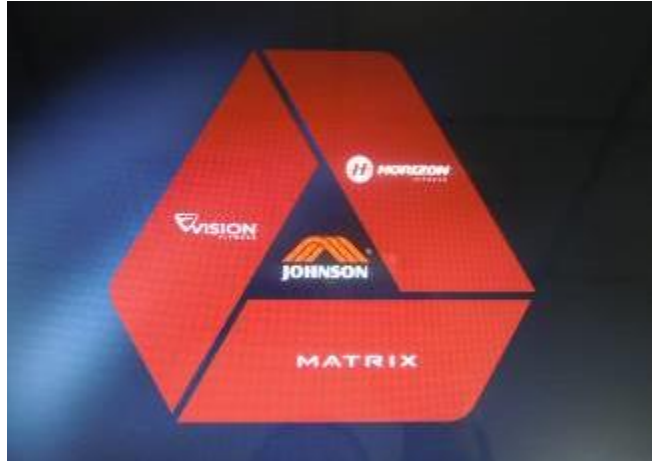
Symptom 1 - Console always frozen at the Johnson triangle logo :

The issue usually occurs after a software update.

Symptom 2 - Console boot up is delayed or console can't boot :

Console is frozen or remains at the Johnson triangle logo during boot.

This is an OS software (Symptom 1) or UCB issue (Symptom 2).

Cycle power the console and count to 15 before turn the power back. Check to see if the power up was successful.

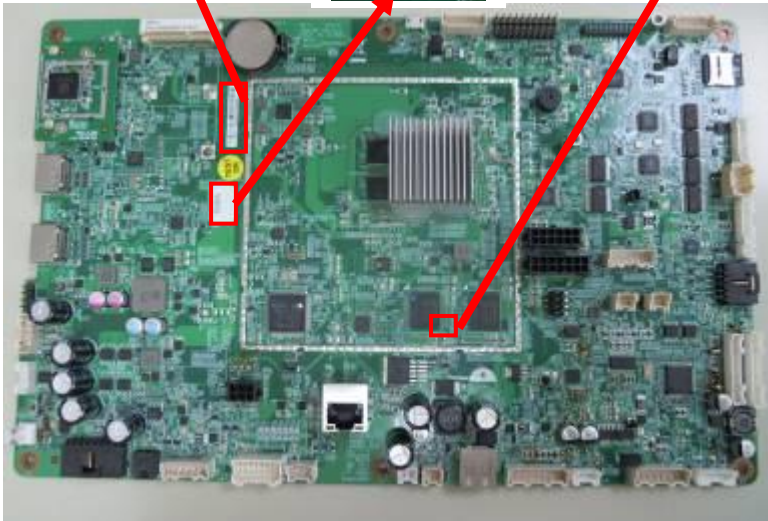
Replace the UCB. JHT has improved the UCB. The design change summary is shown below.

1.3 The components that were changed are capacitors **C594/C586 (30pf)**.

1.1 The starting S/N of new UCB is **TBBG11025063**.

1.2 The starting edition of new UCB is **60JG**.

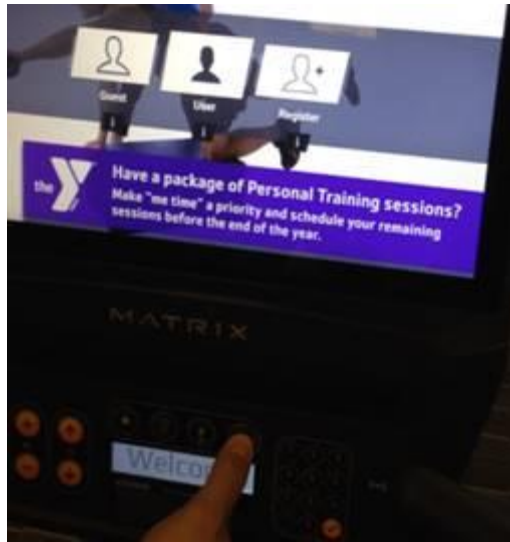
There is no touch panel reaction, but the keypad is working.

This is an OS software issue.

1. Press "Enter 9 9 1 1 Enter" on the keypad, and then reboot the console. Next, check for software updates and install all updates to latest version.
2. Run Android Recovery , updates and install software process again.

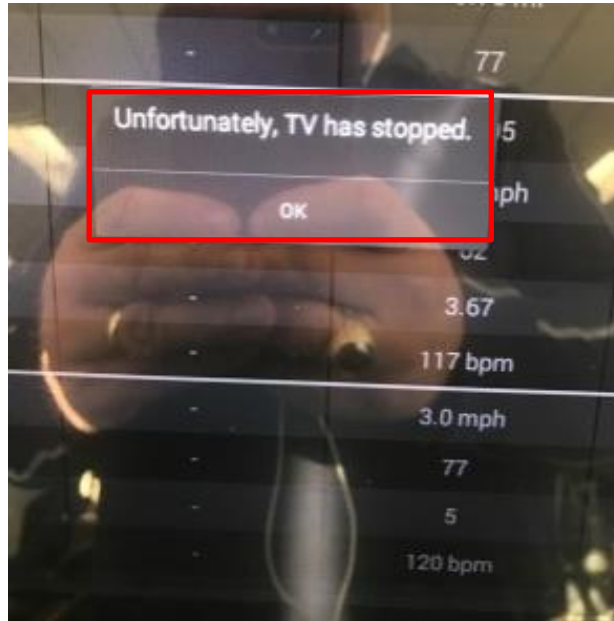
Console shows “Unfortunately, TV has stopped.”

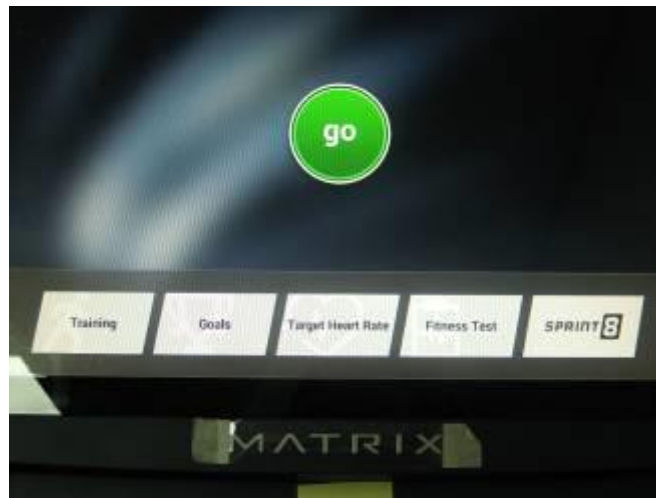
There is no VA button on the Go screen.

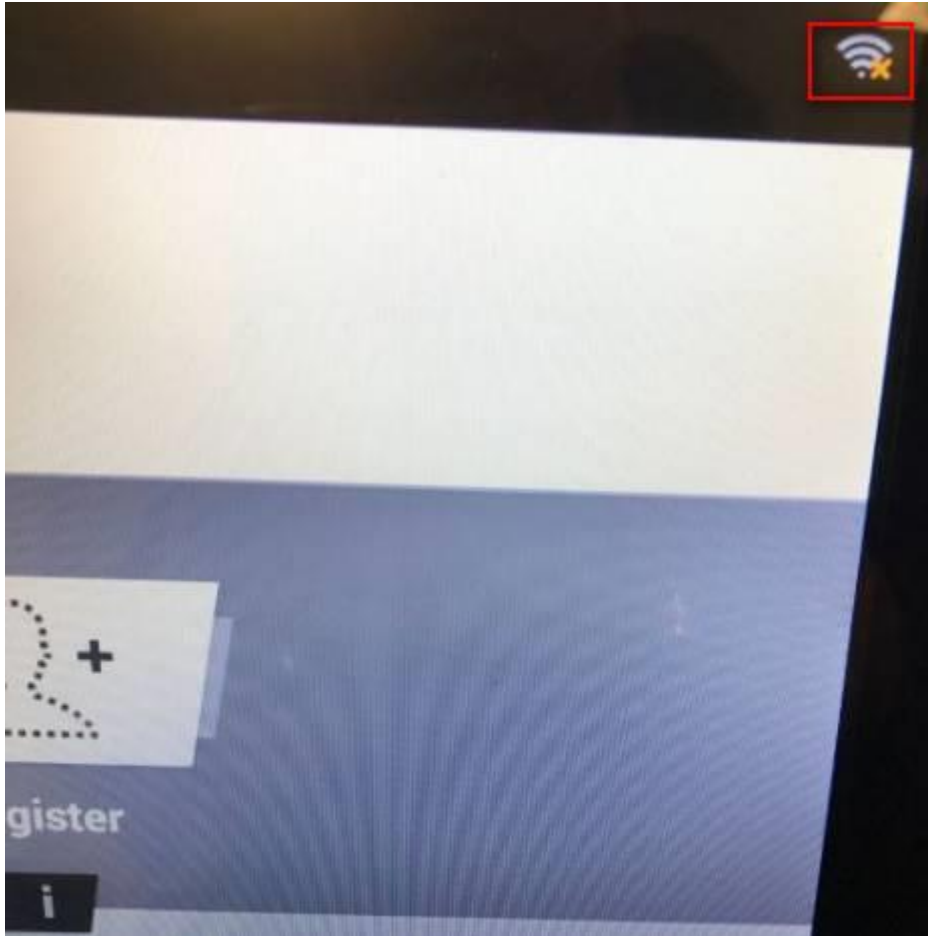
Wi-Fi is working, but the icon shows an X symbol (DPAI isn't connected).

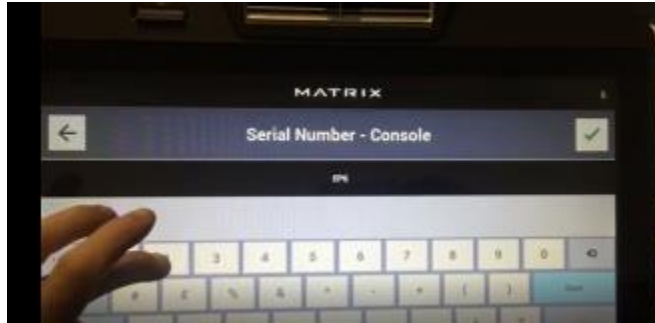
The touch panel does not respond after changing the touch panel or UCB.

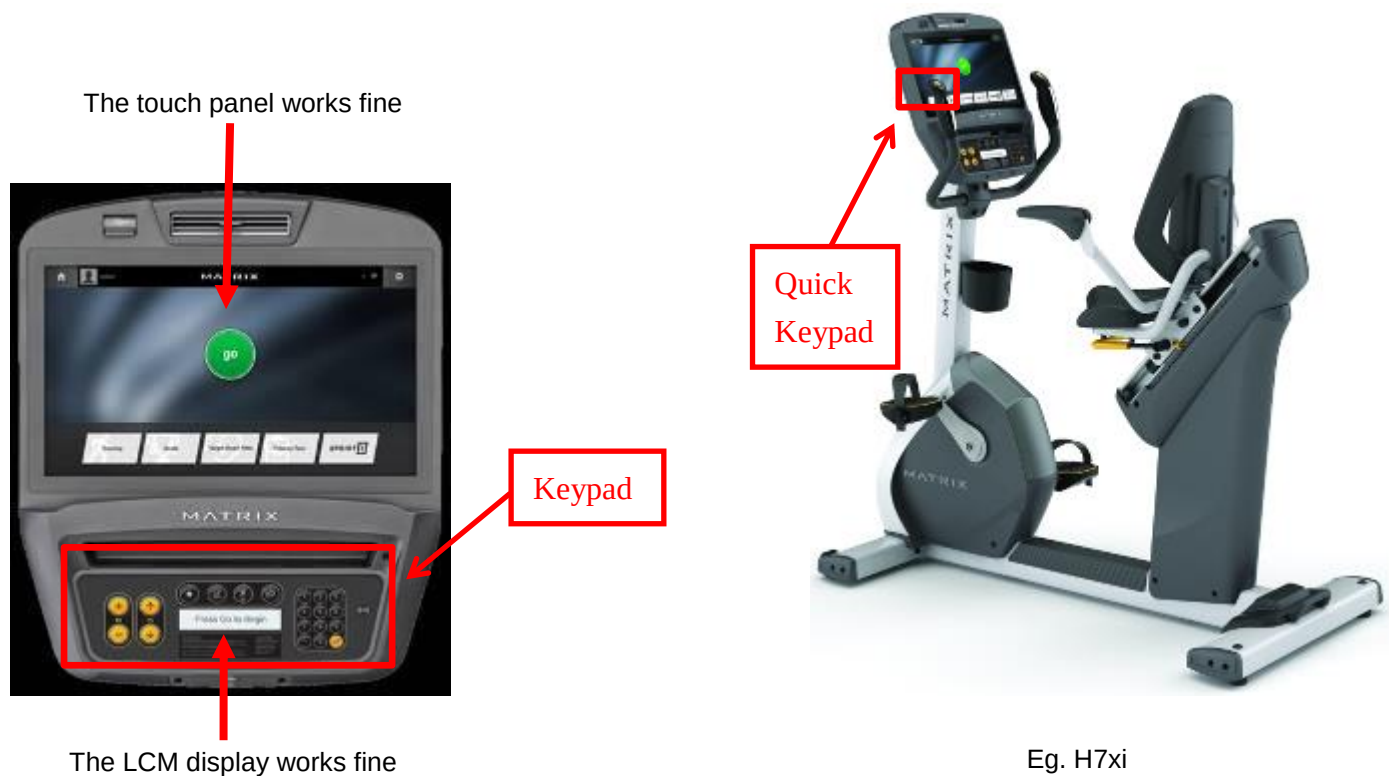
There is no reaction from any of keypads or quick keys.

This is keypad wire connection or the LCM Control Board Set issue.

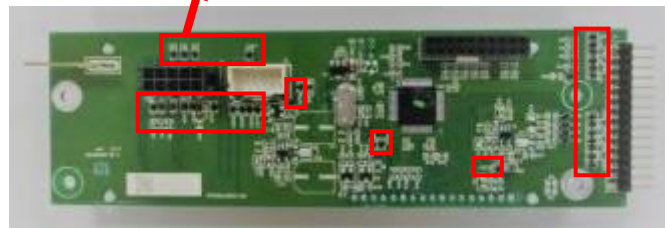
New – LCM Control Board Set

New TVS diodes- e.g. VZ3/VZ1/VZ7/VZ27

1. Replace the LCM Control Board Set. JHT has improved the LCM Control Board Set.
2. The major change components are TVS diodes VZ1~VZ9, VZ10~VZ29, VZ36 and VZ37.
3. The starting S/N of new LCM Control Board Set is **1738102197**.
4. The new application starts from November, 2017 (plan).
