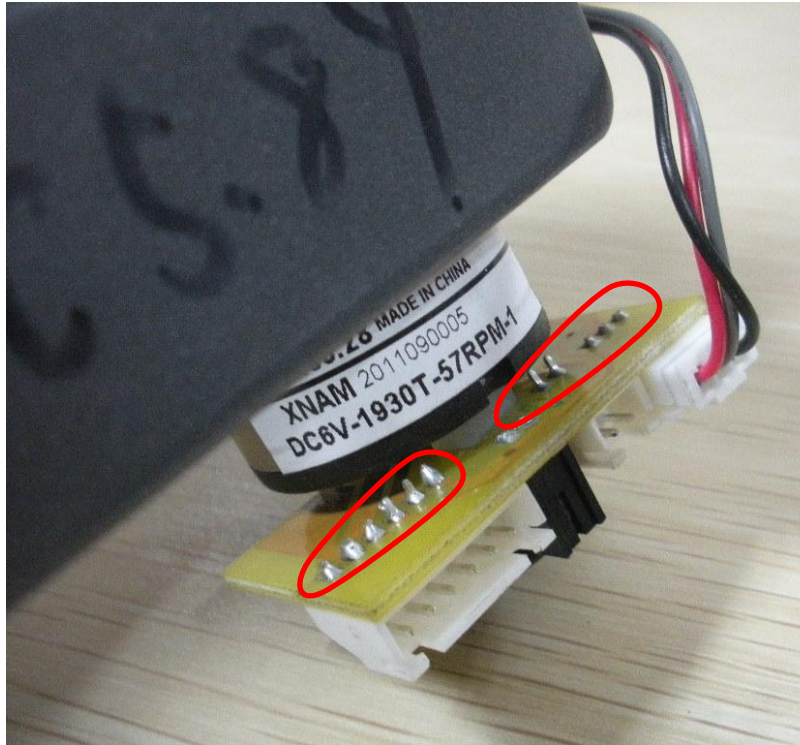
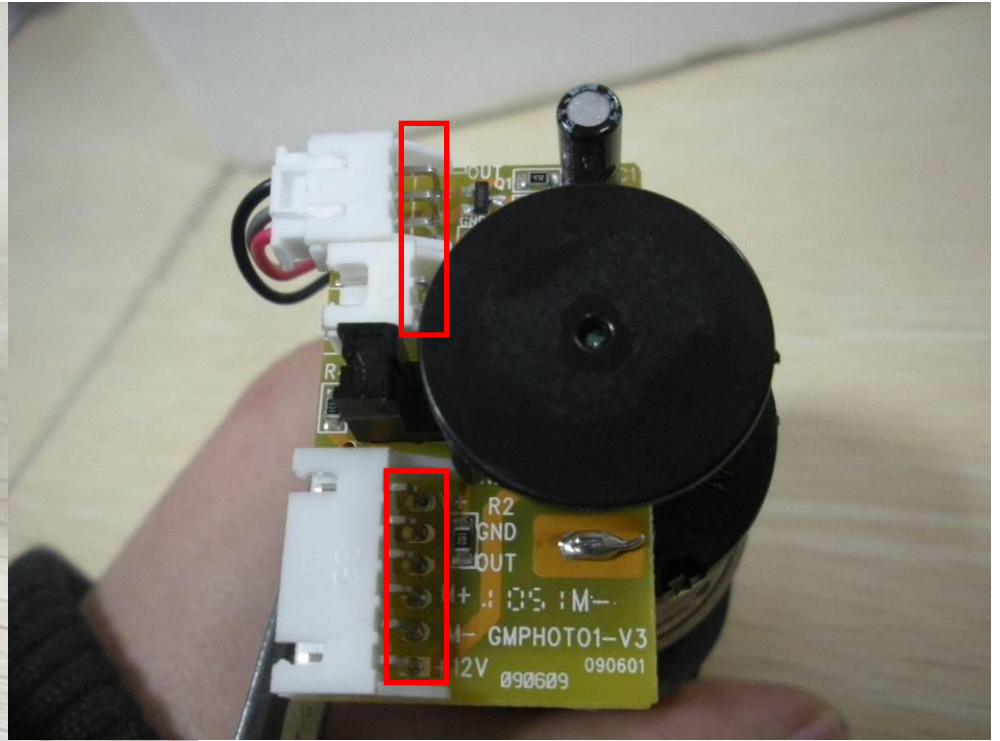
Regarding the motor had been modified after July 2011, you don't realize it has been improved from appearance, due to the motor supplier just improved the welding technology on the integrated circuit board as the red circled photos

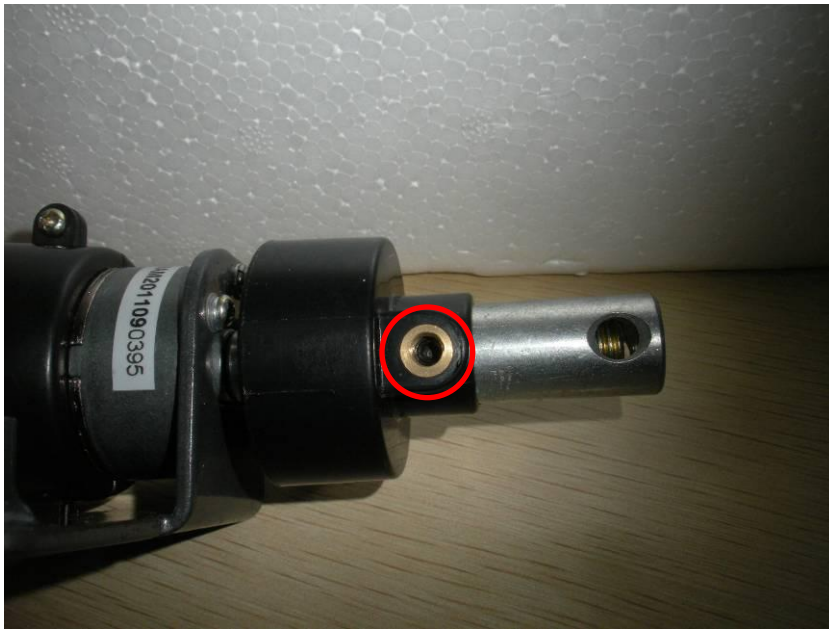
If the limited screw could be loose on the limit ring before shipment, it caused to sleeve screw out of threaded rod

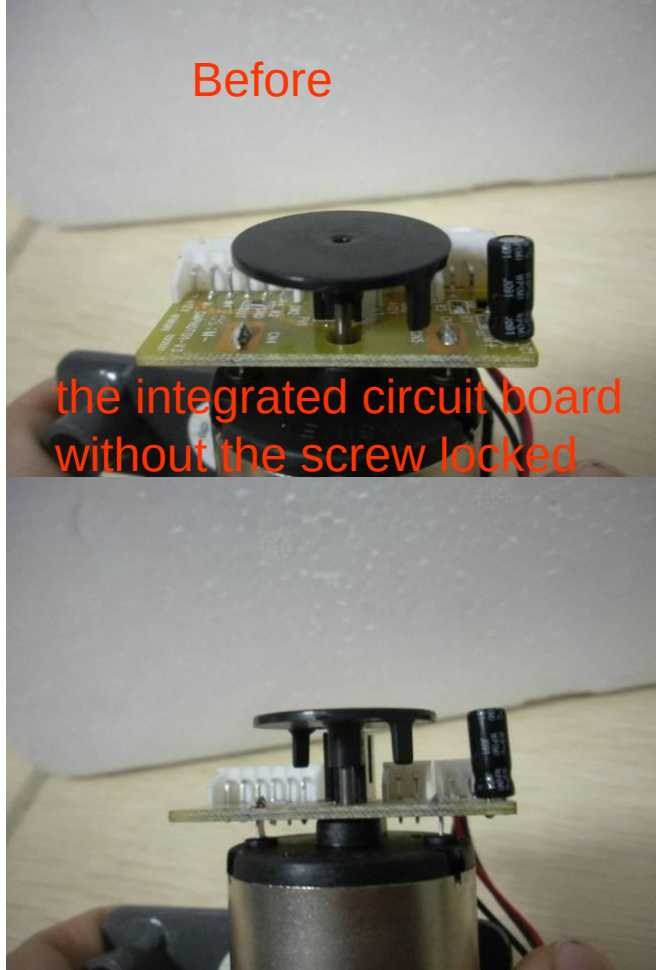
Before

The integrated circuit board could be shake up and down when motor keep driving, so it could cause the count disk to hit the sensor to destroy .At that moment the motor would be scratched itself to create grinding noise. As for this defect, motor supplier added extra 3 screws to fix the integrated circuit board as the following photos show
