| <b>MATRIX</b> | Troubleshooting Guide:<br>2016-2019 Xer & Xir Console Troubleshooting Guide | |
| Prepared by:<br>J.Sleppy | Date Prepared:<br>4/19/19 | Models Affected:<br>2016-2019 UREACT Xer & Xir<br>consoles<br>(CTM698, CTM699) |

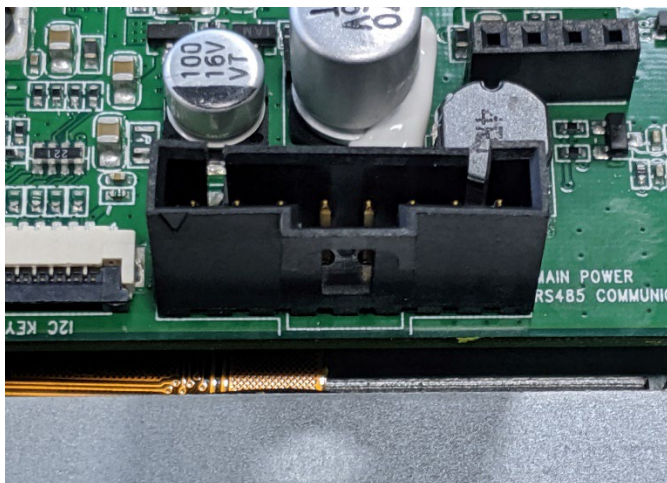
- When replacing a console, the console cable connector (header) could be pulled from the board, and inadvertently installed upside-down—the new console will not work in this configuration. Correct orientation has the clip down, away from the board.

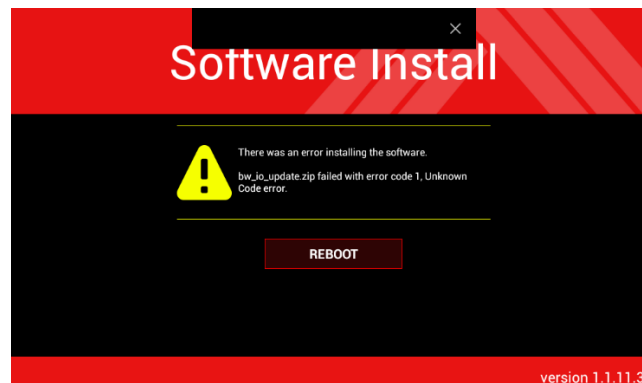
The R&D team is aware of this issue and is working on a long-term solution. In the short term, resolve the issue by using the power switch on the frame to cycle power. If the issue persists, download the console software from the Matrix website to a USB flash drive. Use the “Update from USB” option to reinstall the console software. (Prior to the reinstallation, the console will likely show the IO version as 0.000.)

If the user presses the REBOOT button on the screen above, they may report the following symptoms. Perform a hard power cycle (using the power switch on the frame) to resolve these issues:

- The console loads as normal, but the energy saver light remains on. If the user presses any key, an Android window displays; the window prompts the user to power down or activate Airplane Mode.
- If the user taps power down on the prompt, the screen displays “Shutting down...”, but the loading circle underneath the message continues to loop indefinitely. The console does not shut down.
