# **ELECTRONIC STRIDE ADJUSTMENT SYSTEM TECHNICAL CERTIFICATION TRAINING**

Field Engineering | 2010

# CT08011101R2 – Errors on Activity Zone Display

## CT09030301N – Activity Zone Control Board Connector

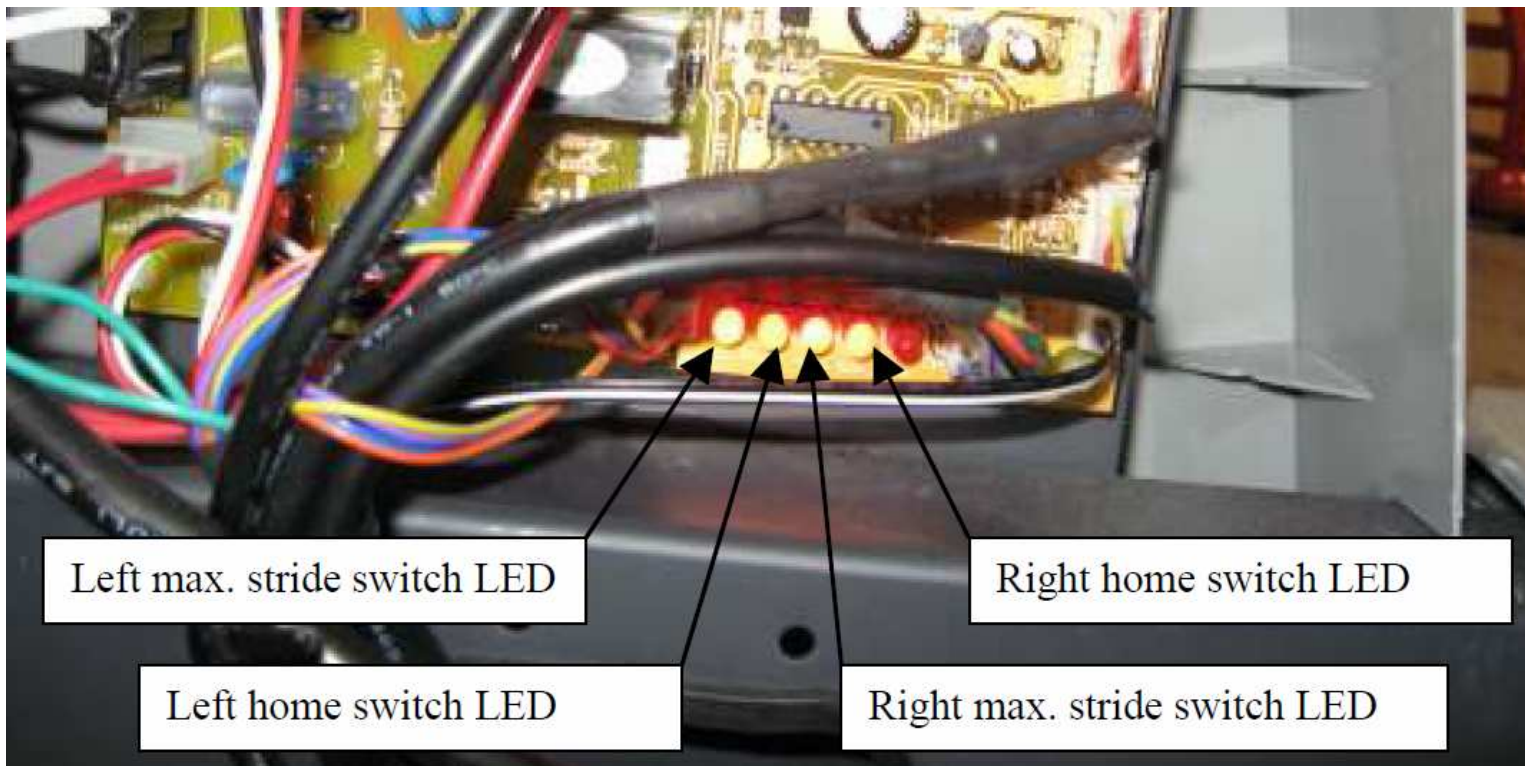
- ♦ Activity zone lights up with blank screen
- ♦ Both actuator motors run up past the maximum stride position until they reach the end of travel.
- ♦ Motors heat up until the internal thermal protection switch cuts off power. A burning smell would likely be given off by the motor.

- ♦ Intermittent connection between the limit switches and the Motor Control Board:
  - > Damaged limit switch wires
  - > Damaged idler link cable

- ♦ If any of the LED's are off and no switch is actuated, you must determine if the cause is a bad switch assembly or if the wire from the switch to the control board has a broken wire.

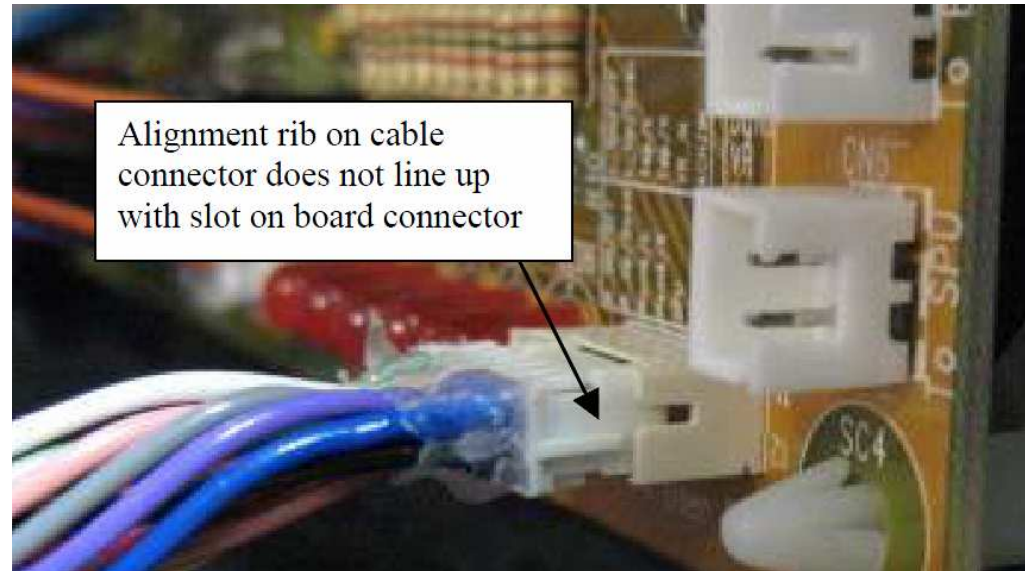
- » Service Bulletin:
- » **Failures reported:**
  - ◆ Activity Zone lit up but screen is blank.
  - ◆ Both actuators at maximum position
  - ◆ Heating up/Burning smell in motors

- ◆ Cable from AZ to Motor Control Board installed upside down at the Motor Control Board
