| <b>Effective Date:</b><br>10/5/2011 | <b>Service Bulletin</b> | <b>Revision</b><br>001 |
| <b>Warranty:</b><br>Depends on Install Date | <b>Diagnosing Noise Issues on Sporting Good<br/>Elliptical Trainers</b> | <b>Revised Date:</b> |

## DESCRIPTION

Noise issues arise after installation or after use.

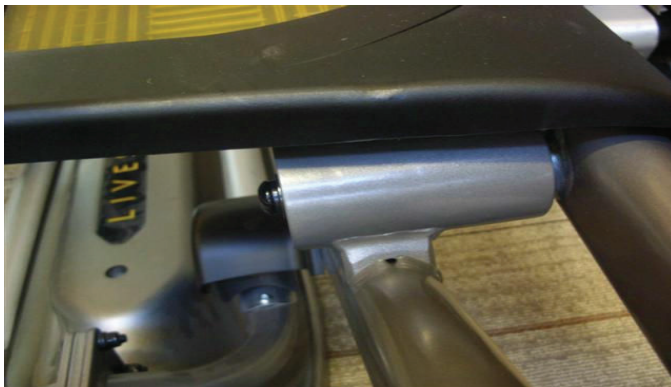
Figure A

1. Check the link arm / pedal arm connection for a loose bolt (Figure A). Lubricate the shaft with lithium based grease (Figure B). This bolt should be torqued to approximately 6 N-m.

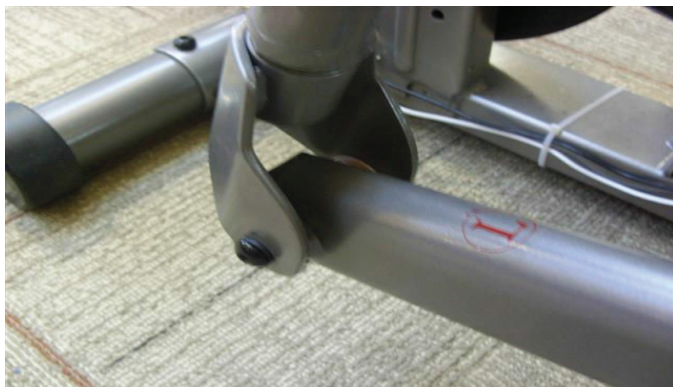
Figure C

2. Check the link arm / handlebar connection for a loose bolt / nut (Figure C). Make sure that there is a Teflon washer on each side of the link arm (Figure D). This bolt should be torqued to approximately 10 N-m.

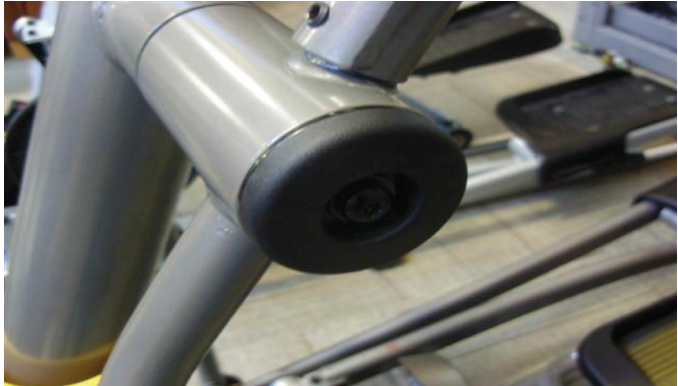
Figure E

3. Check the handlebar / console mast connection for a loose bolt (Figure E). Lubricate the shaft with lithium based grease (Figure F). This bolt should be torqued to approximately 6 N-m.

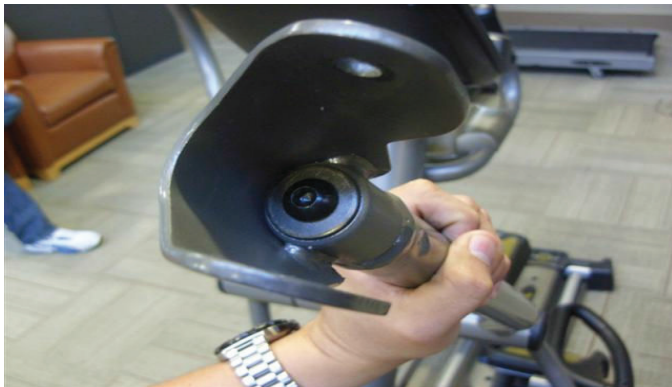
Figure G

4. Check the bolt holding the lower portion of the handlebar to the rest of the handlebar (Figure G). **NOTE:** On some models, this piece will be welded to the rest of the handlebar (like in Figure H), and does not need to be checked. This bolt should be torqued to 6 N-m.
