# Tank disassembly and service guide E520/E720/E820/E920

Note to Service Technician:  
This service guide covers complete tank disassembly with special emphasis on main-shaft/flywheel removal and tank seal replacement.

# Mainshaft seal spring report

# Tank main shaft seal replacement service guide:

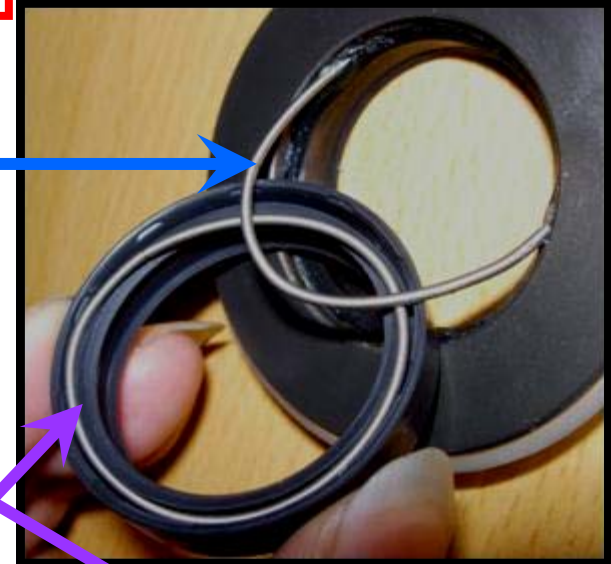
A correct spec stainless steel mainshaft seal spring after 6 months in water, and 4 years after production, alongside our current stainless spring. As pictured, the springs are identical.

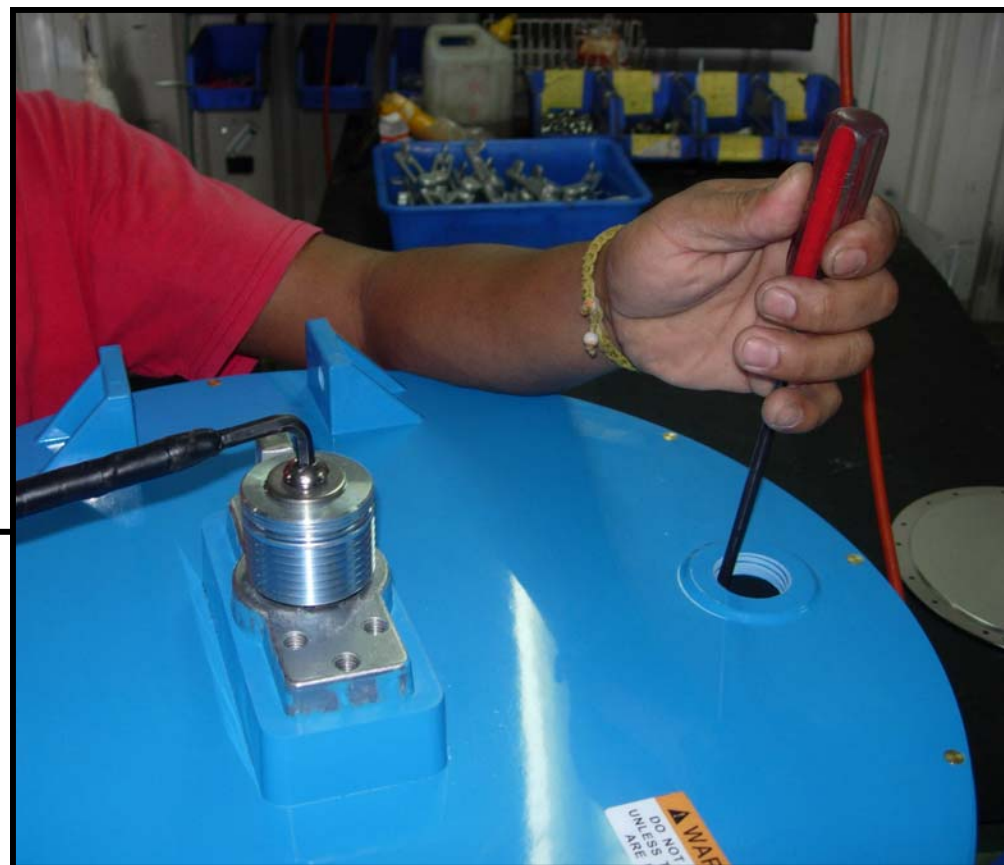
Step 3: Using a screwdriver or suitable tool, lock the impeller blade in place and remove the rear main-shaft bolt.

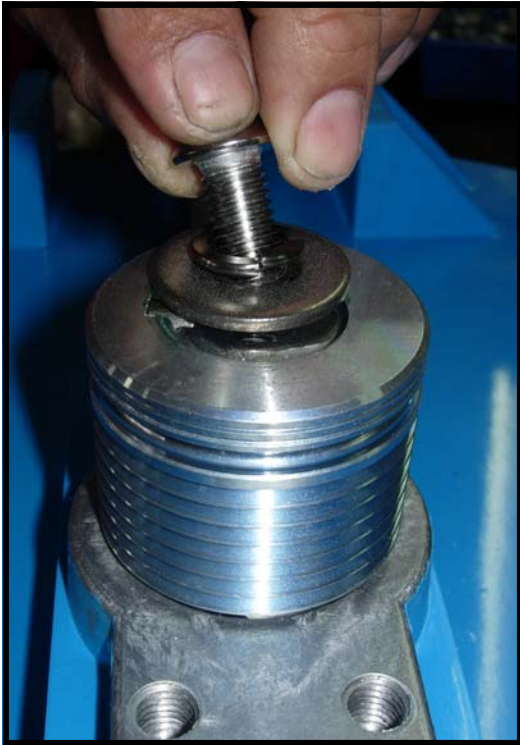
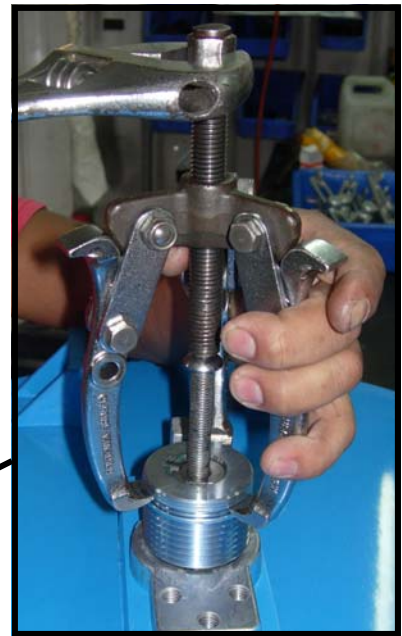
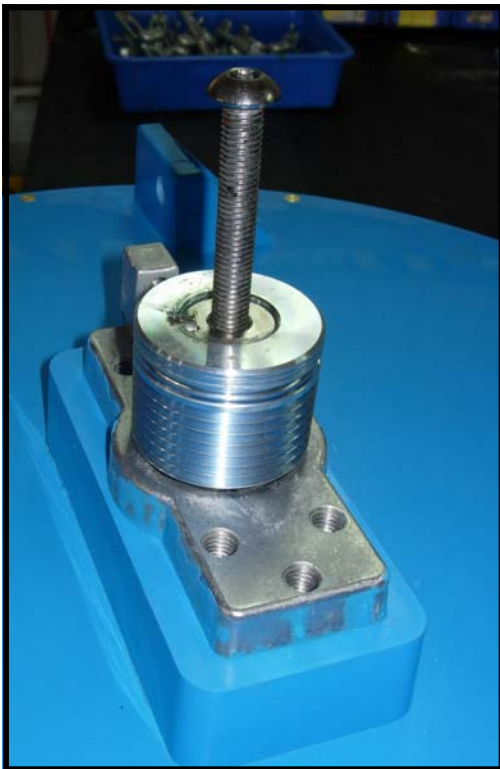
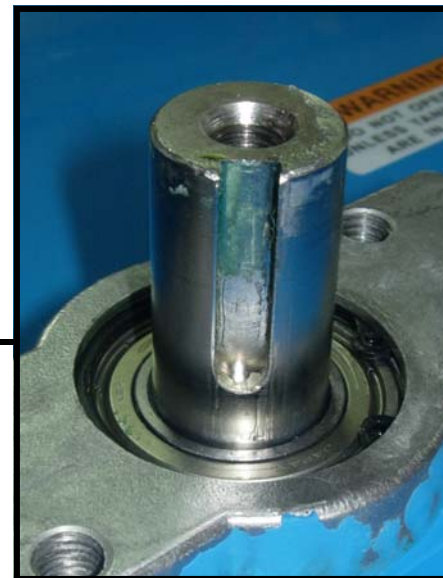
Step 4: Remove Main shaft rear bolt and washer.

Step 6: With a standard bearing puller, begin threading the pulley off the main shaft. Once the pulley has some clearance away from the rear of the aluminum housing, reposition the bearing puller to the bottom of the pulley for easier removal as shown below.

Step 5: Screw a M10x (at least 70mm) bolt into the main-shaft.

Main shaft shown after small pulley, keyway, washer and bolt removal.

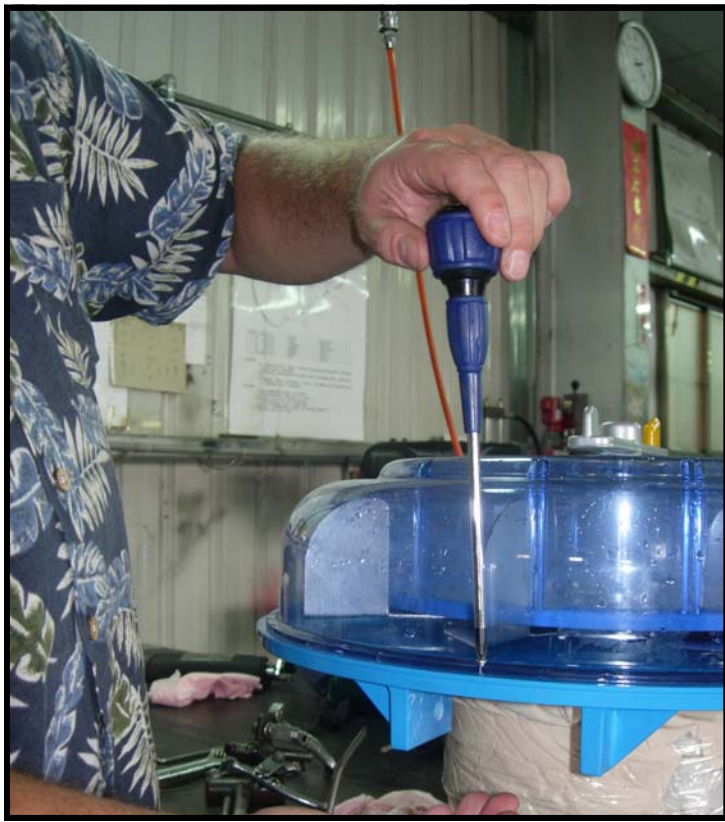
Step 1

Start by removing Polycarbonate shell. Once the M3x12mm tank screws (12x) have been removed, use a rubber mallet and drop cloth and tap gently to break loose the outer tank seal. Remove the upper section of the tank, and inspect the O-ring for any signs of cracking tearing or binding. Replace if needed.

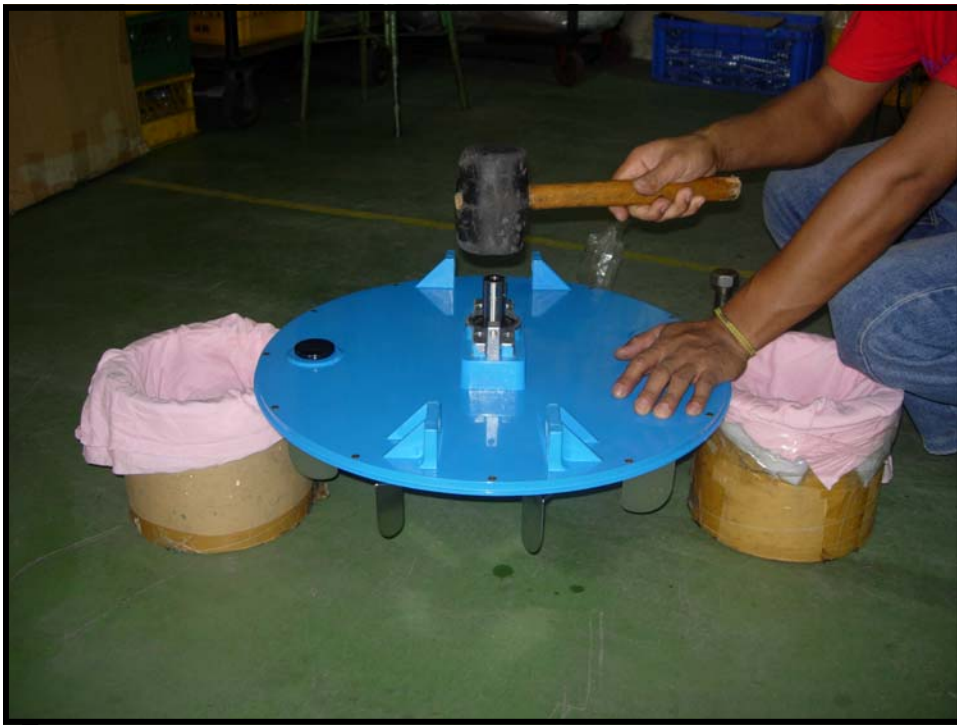
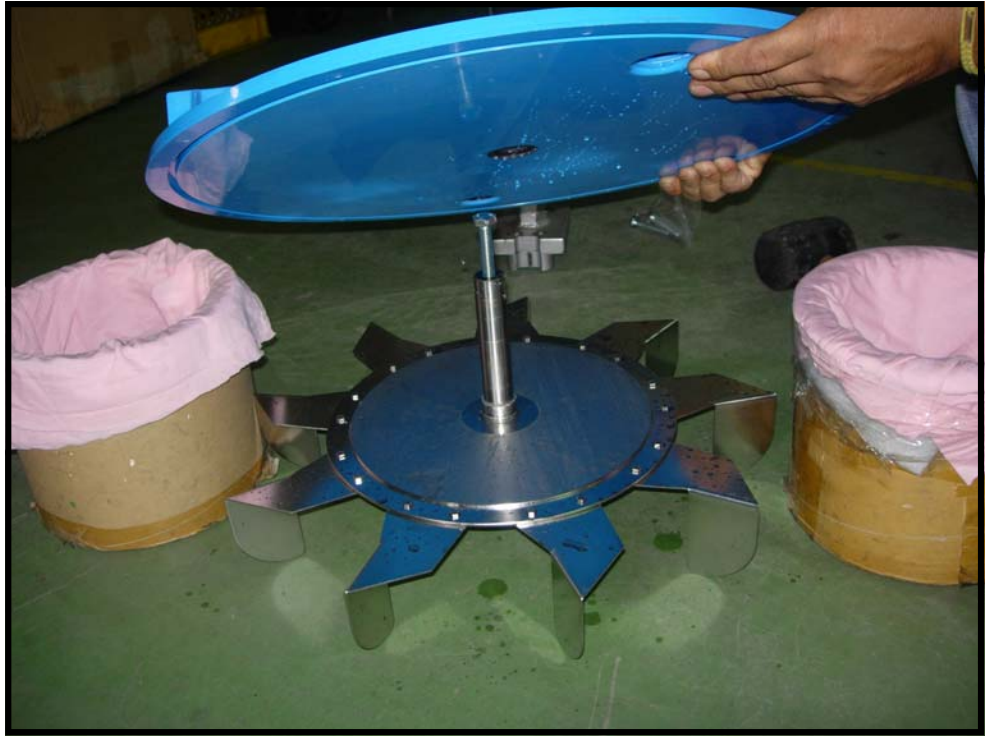
Next, flip the tank back over and find a suitable location to drive the flywheel mainshaft through as pictured; such as the ends of two tables, workbenches or even two chairs. Use a rubber mallet to drive the mainshaft through the tank-back. Screw a M10 bolt into the mainshaft rear to help drive the mainshaft out as shown.

Note: The flywheel mainshaft is heavy. Allow the assembly to drop onto a soft surface underneath. The impeller blades are also sharp, use care when handling.

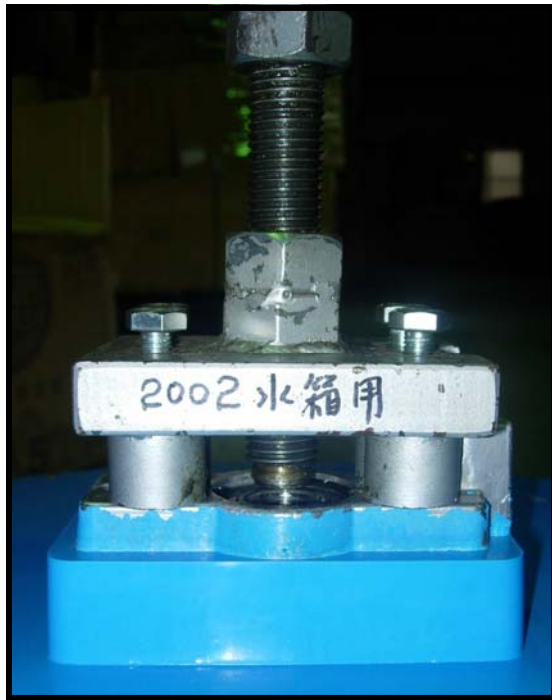
First, attach the FDF flywheel shaft puller to the rear of the SMC tank aluminum housing and tighten the four bolts as shown. Then, with a large open-end or crescent wrench, slowly turn the main puller bolt clock-wise until the flywheel is forced through the housing and out of the tank.

Note: Use a towel or other soft surface underneath to avoid damage when the flywheel/mainshaft assembly drops out of the housing.

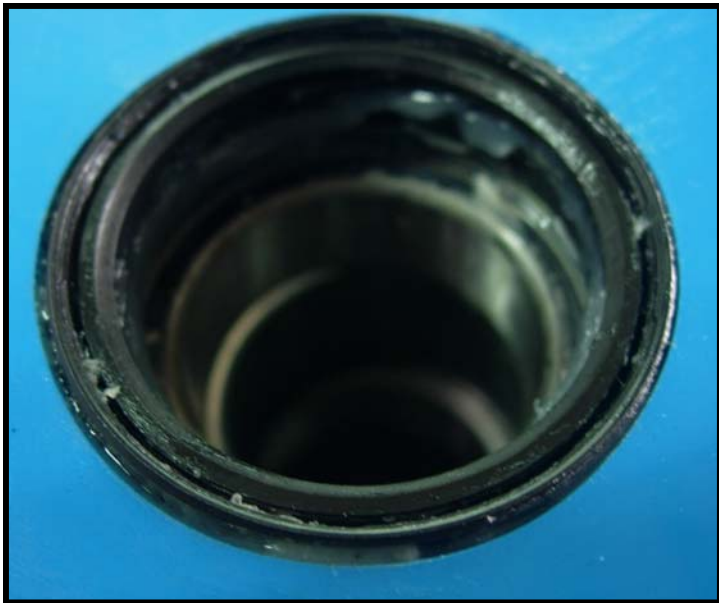
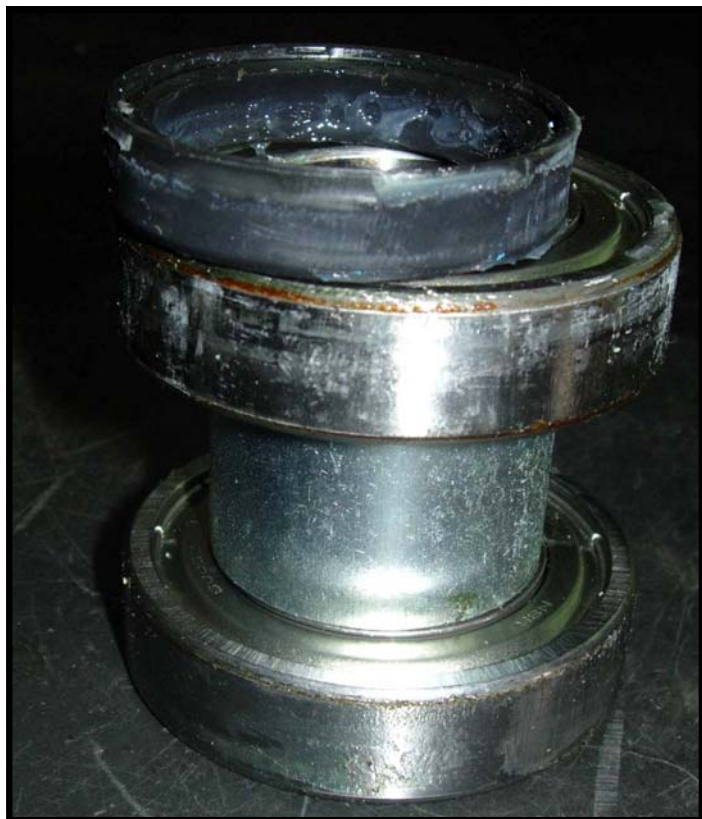
On the left is a healthy tank shaft seal, the silicone glue and packing grease maintain their original color. The integrity of this tank shaft seal has not been compromised. The bearings will show no sign of water damage and run smoothly. If there are no issues with the tank bearings, the bearings and tank shaft seal can be left in place and the tank re-assembled.

The right seal has been compromised. Telltale signs are the discolored silicone and the propensity for the tank seal to pop out of position when the main-shaft/flywheel assembly is removed. The seal (part number 10025) tank bearings (part number 10012) spacer (part number 10145) and C-clip (part number 10186) will be replaced in the tank shaft seal kit.

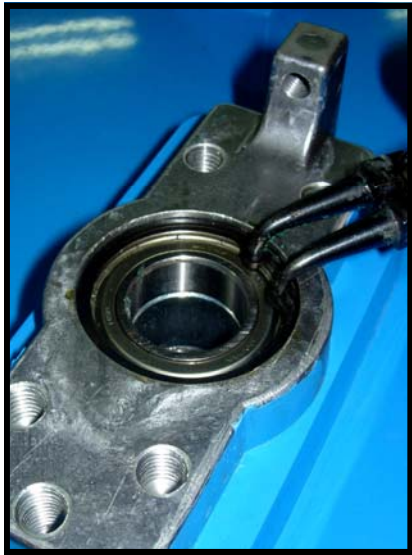
1. Remove C-clip from rear of aluminum housing

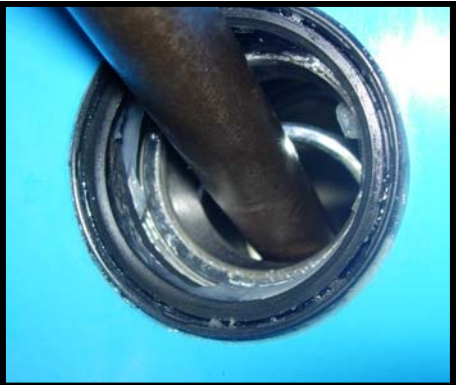
2. With small drift and hammer, lightly tap out and remove the rear bearing

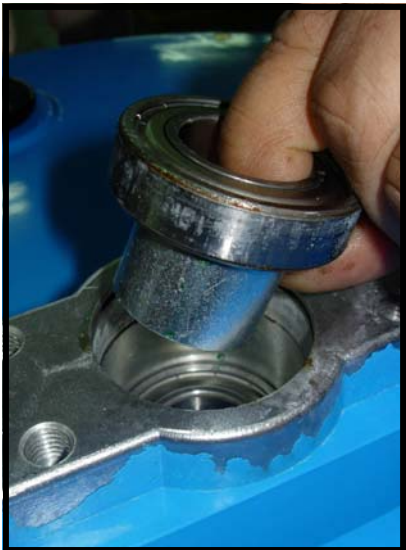
3. Remove Rear bearing and spacer

4. Tap out the front bearing and remove

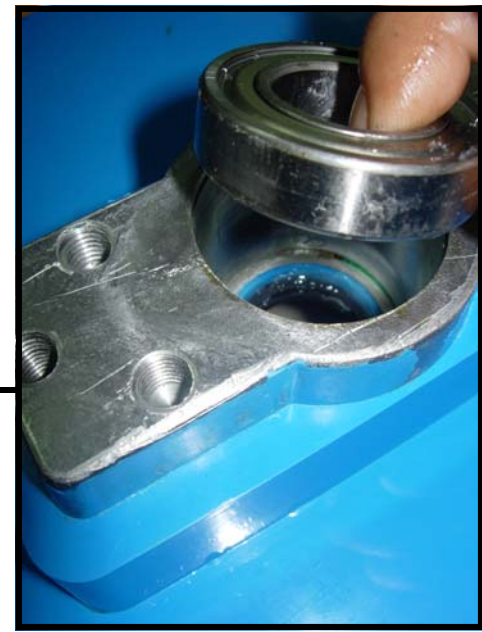
5. Lightly tap out the mainshaft seal and remove

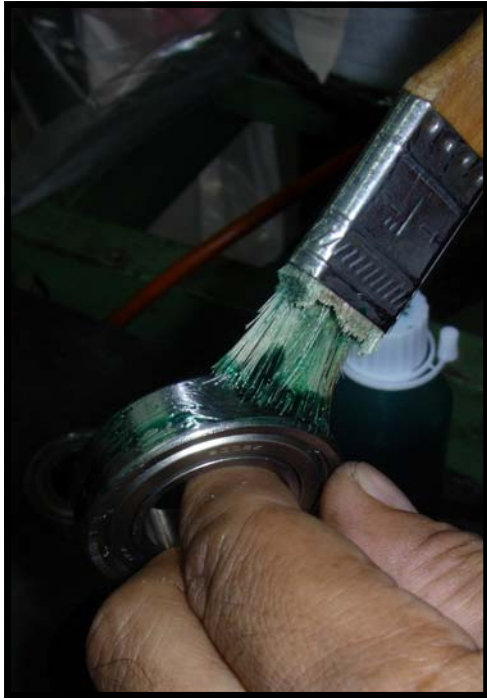
1. Clean inside of aluminum housing. Add thread locker to the outside of the bearing and to the inside of the aluminum housing where the two bearings will be located. Note that the service tech will be required to rig up a tool of some kind to tap the front tank bearing in. An example of the set up we use at the factory is shown below. A simple washer and metal spacer will also work. Check that the bearings are rotating smoothly once seated in the housing.

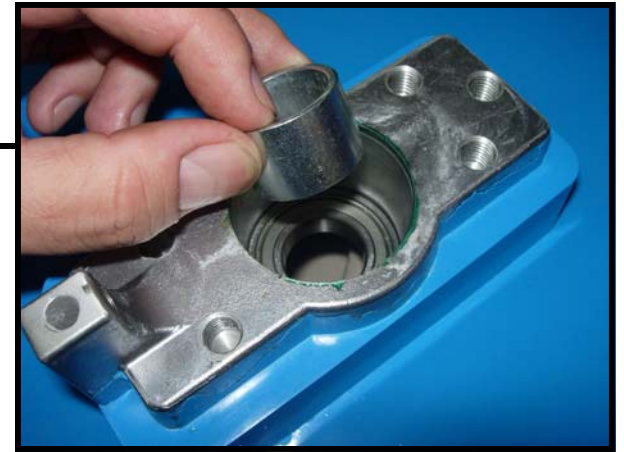
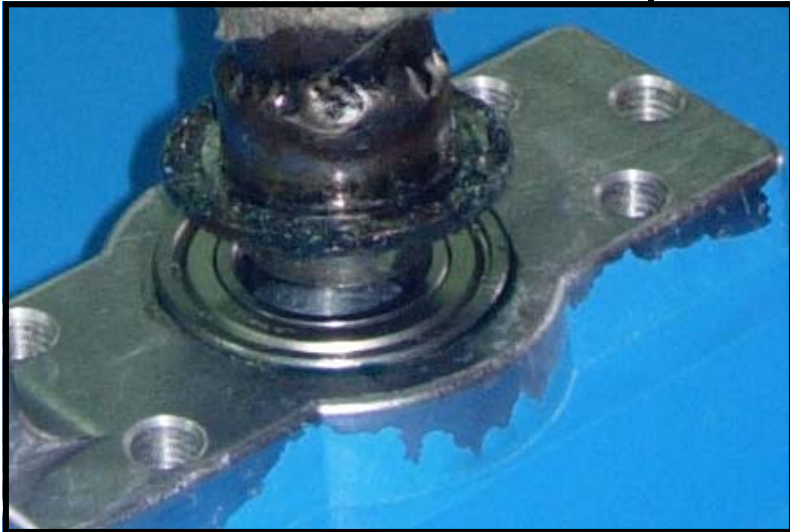
2. Replace Spacer.

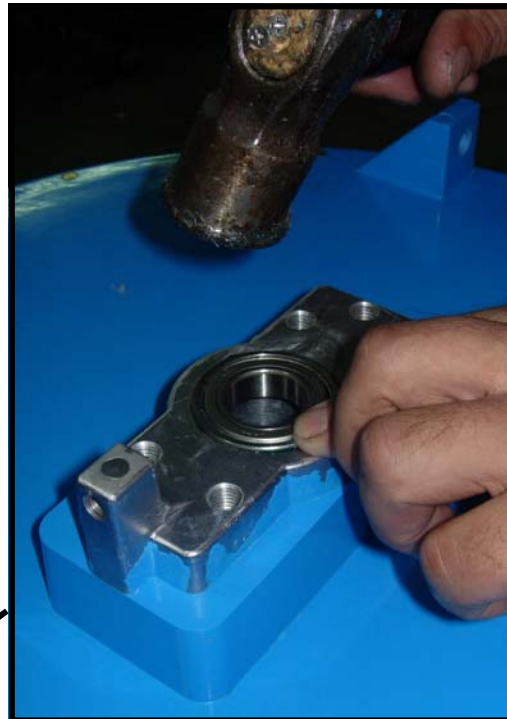
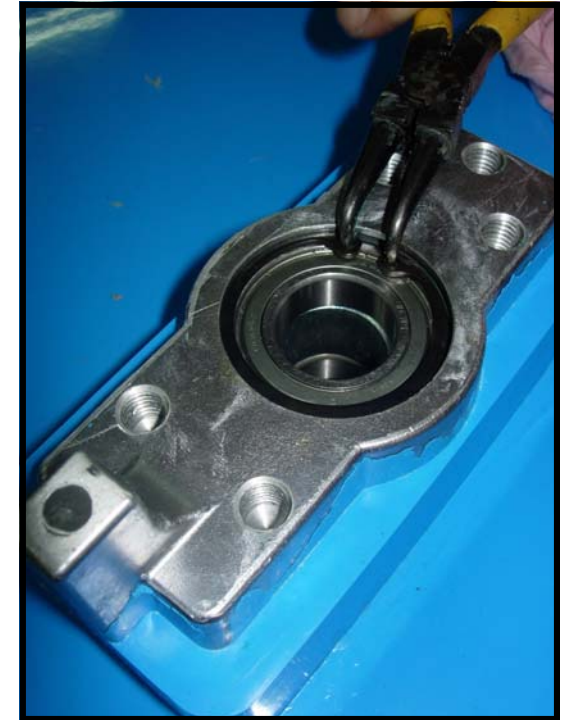
3. Replace rear bearing

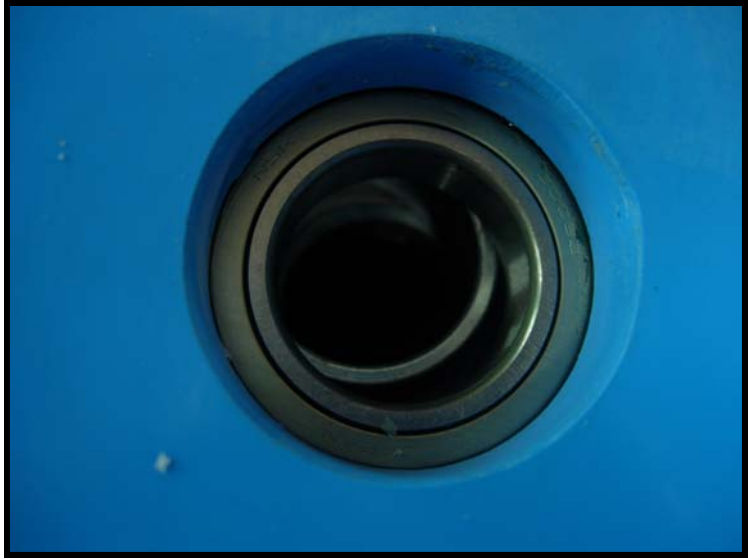
1. Carefully remove any residual matter (silicone glue or grease) from the SMC seal housing walls before pressing in the new seal housing.

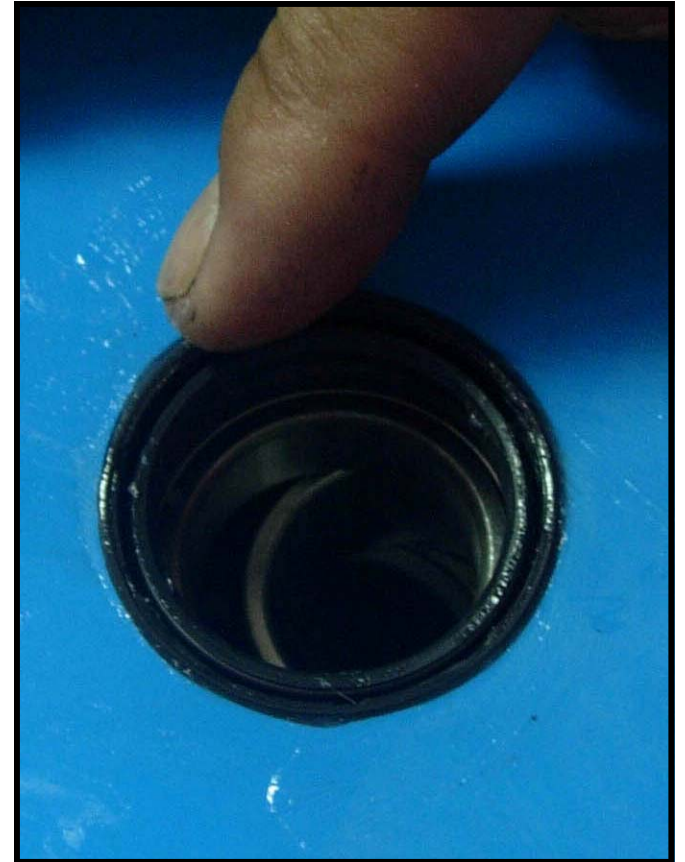
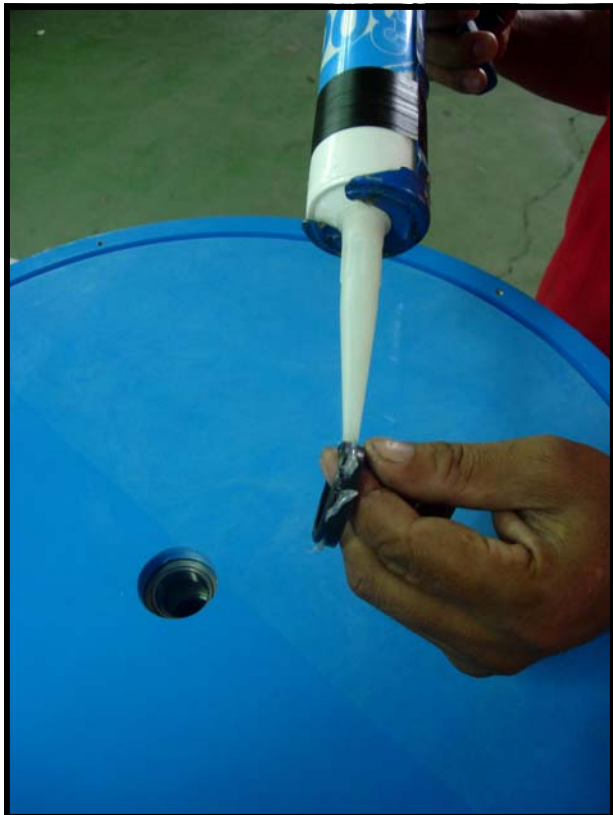
2. Apply silicone glue to the outside of the NBR tank seal prior to pressing the seal into the SMC tank back. Standard fish tank grade Silicone is required.

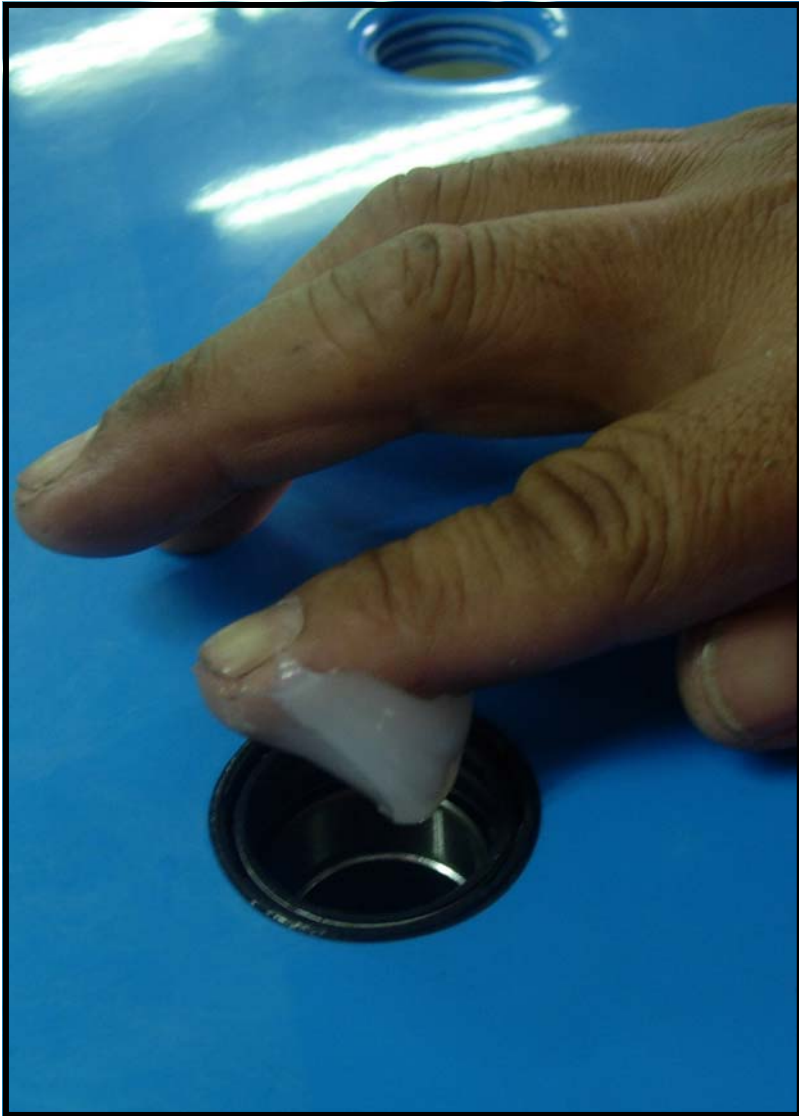
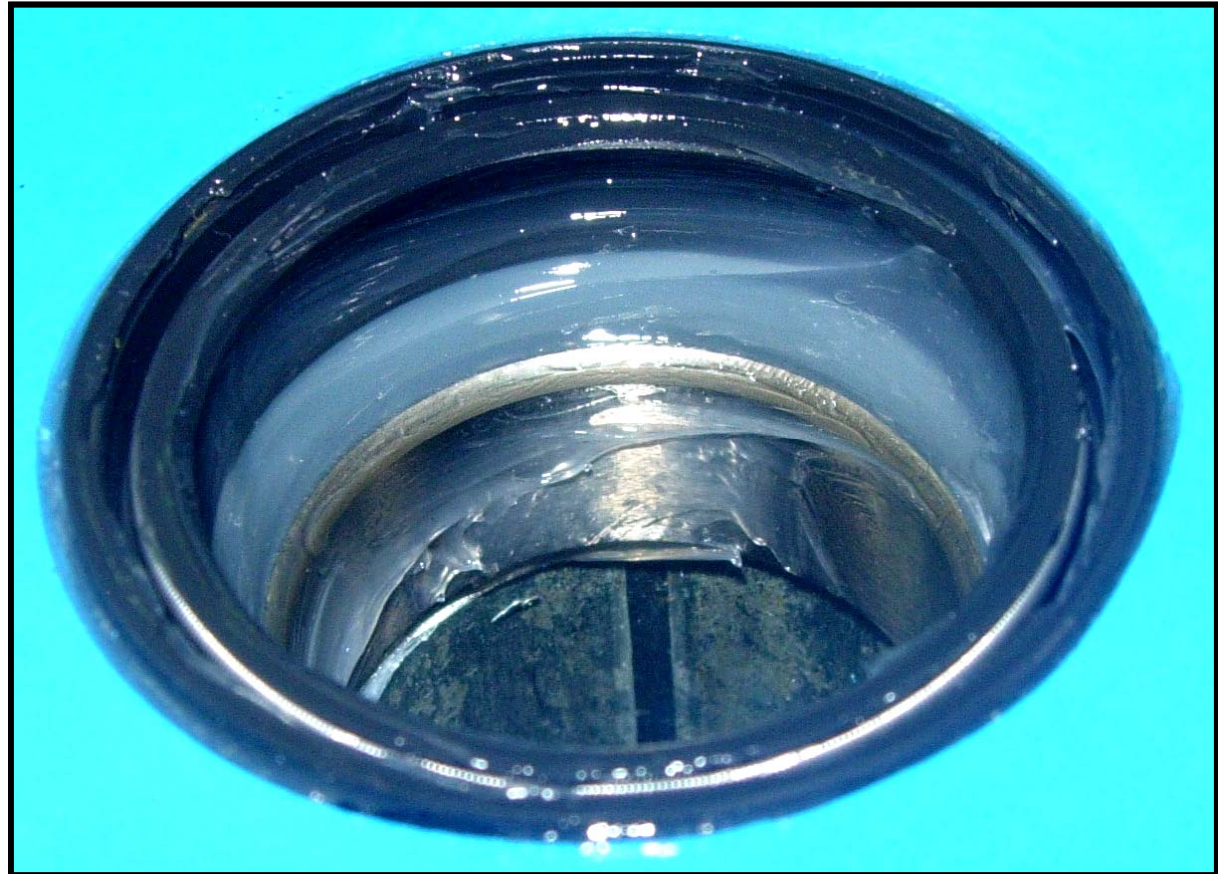
Apply a generous amount of Silicone grease (standard O-ring grease) to the inside of the seal and pack the area between the rear of the seal and the front bearing with a liberal amount of O-ring grease. Above right is an example of a properly prepared tank shaft seal .

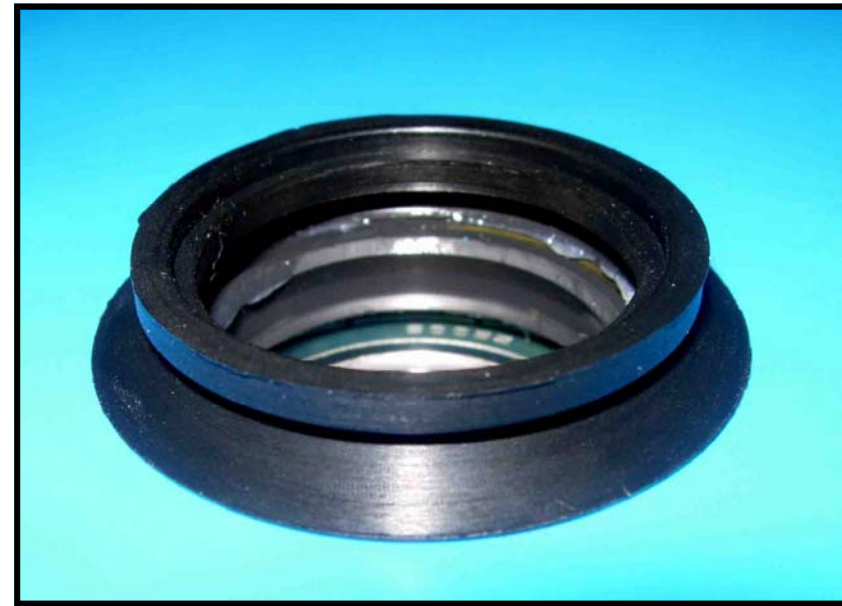
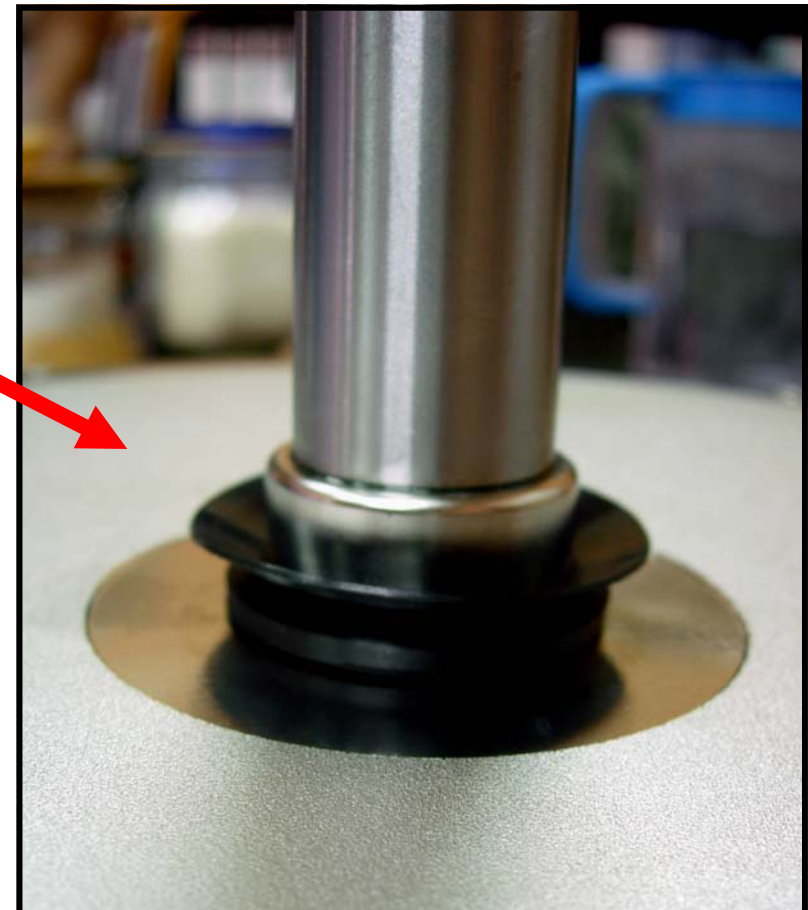
Once the bearings, mainshaft seal and spacer have been replaced, this cup seal slides onto the mainshaft as shown bottom left and right before the flywheel shaft is re-installed through the SMC tank back (as directed in the service notes). **Shown upper right (without the flywheel mainshaft for effect) is the cup seal.** It will help direct water away from the mainshaft seal, thus reducing wear and tear and greatly extending the longevity of the replacement parts. This is especially helpful for the S250/S350 series rowers. Note distributors holding existing FDF9E kits without the cup seal can order them (Part number #13025) FOC by contacting our Production Manager in Taiwan (Note freight charges are the responsibility of the Distributor), Michael Botti. **Email address as follows: [michaeljbotti@gmail.com](mailto:michaeljbotti@gmail.com). Tel: 886 3 478 3306 ext#45**

Slide the cup seal onto the fly-wheel mainshaft juts prior to re-assembly as shown:

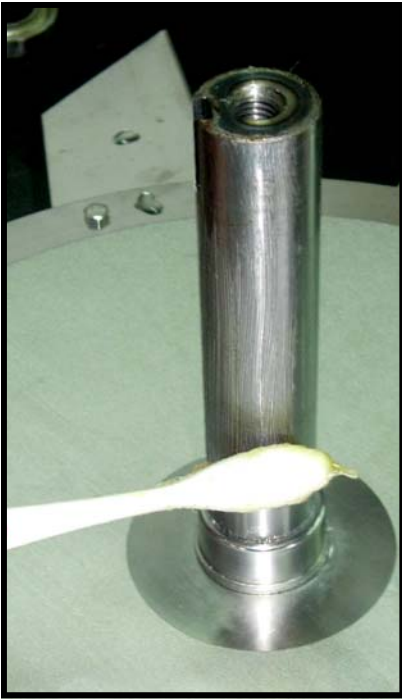
1. Apply axle grease to main shaft before installation.

Note: When pressing the main shaft into the SMC tank back, make sure the bearing spacer is aligned.

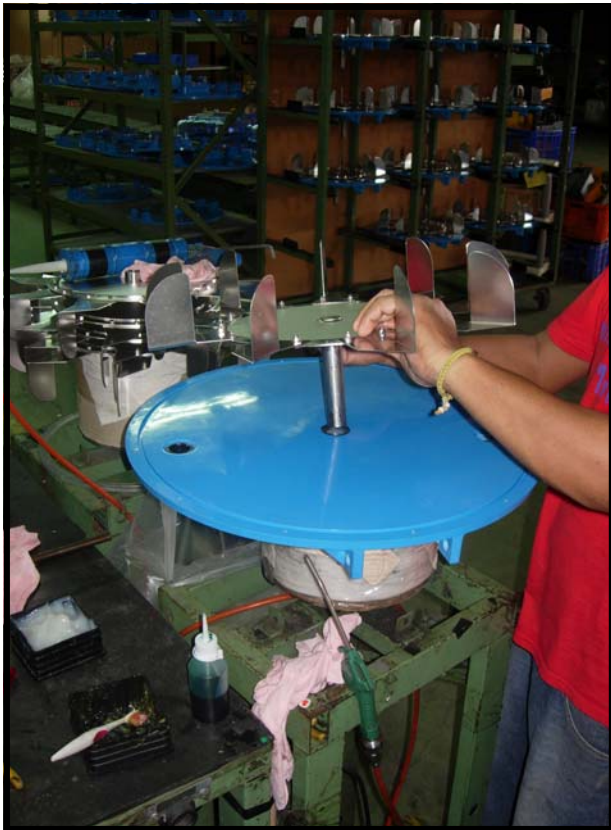
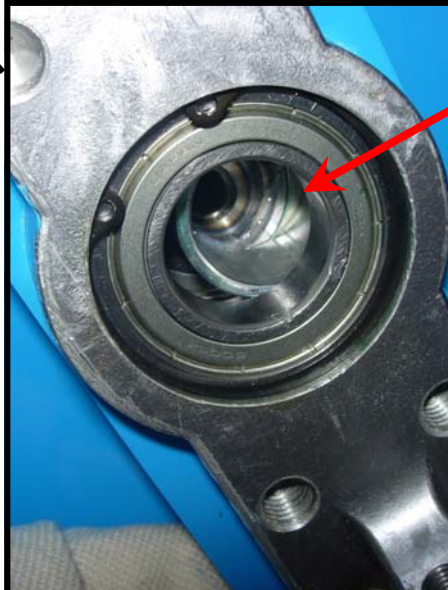
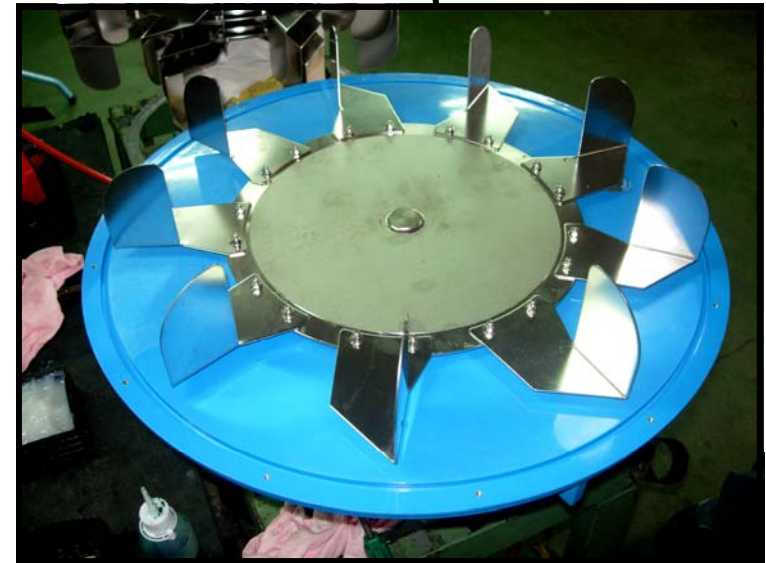
2. Once the Flywheel/ Main shaft assembly has been completed, you may proceed with reinstalling the tank cover O-ring, PC cover and finally whichever drive system is applicable for the tank in question.

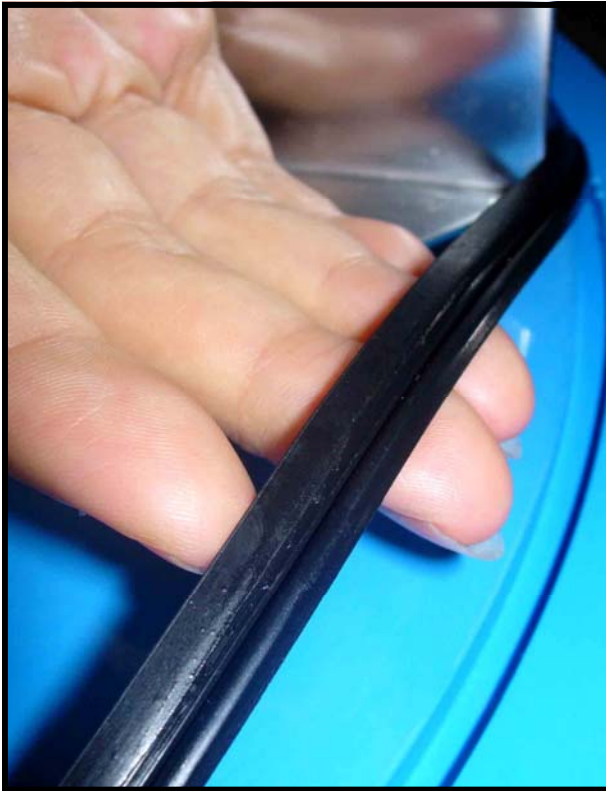
1. Lay the O-ring into the SMC O-ring groove, making sure it is flat and flush before securing the PC cover. An improperly laid and prepared O-ring will seep water over time. If the seal is excessively dry, then add a light coat of silicone grease.

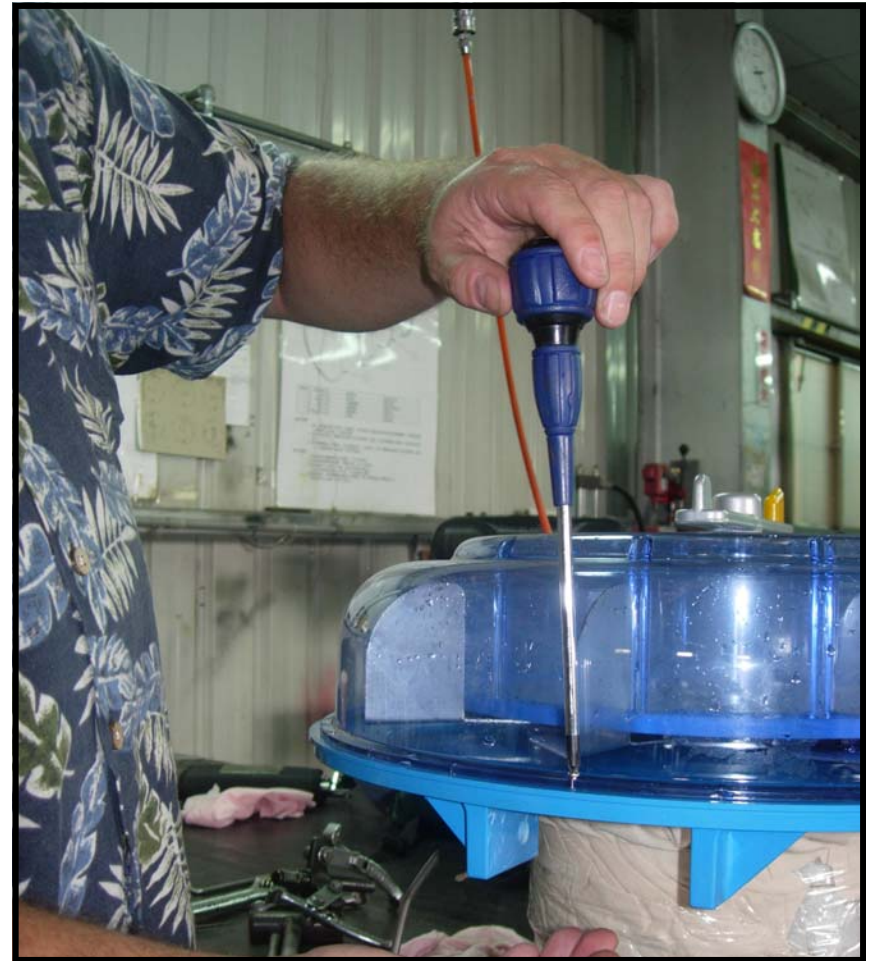
2. When attaching the PC cover, use a cross pattern with the screws. If a power tool is used, the lightest setting is more than enough to establish a seal. **Note over tightening the tank screws will readily crack the PC cover!**

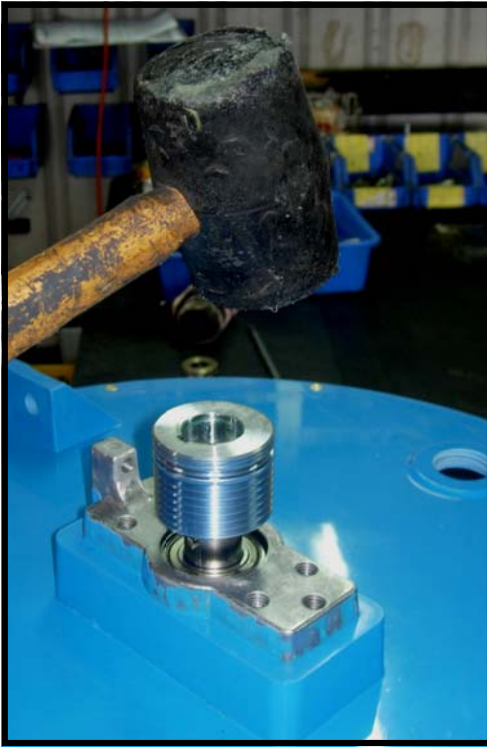
1. Reinstall the Small belt pulley onto the main-shaft. Remember to keep the keyway positions on the shaft and pulley lined up as you go.

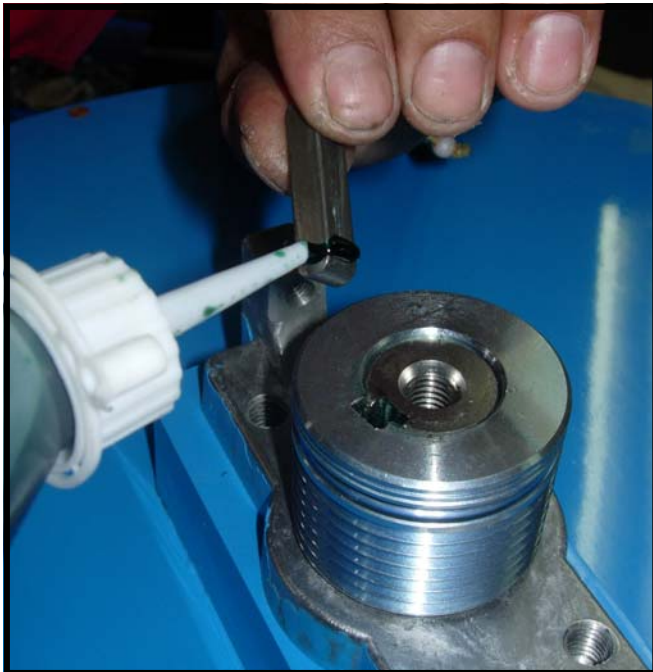
2. Apply thread locker to the keyway before knocking into place. Use a drift or heavy bladed screwdriver to drive the keyway into place as shown upper right.

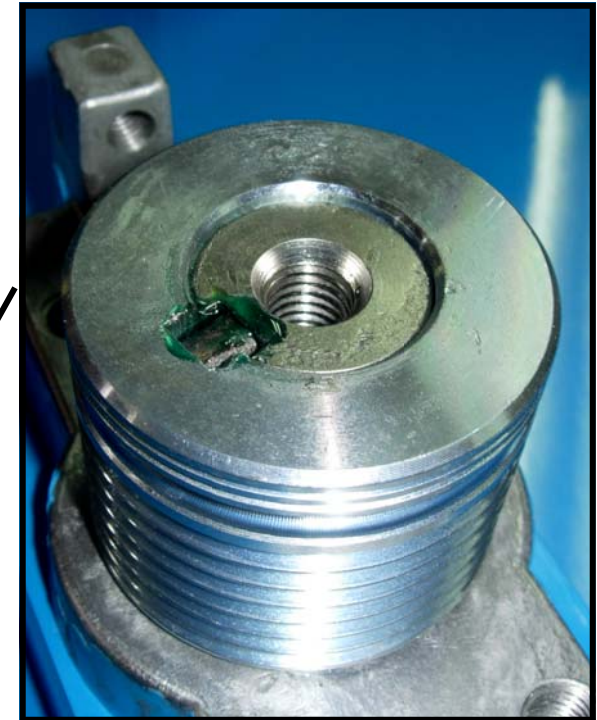
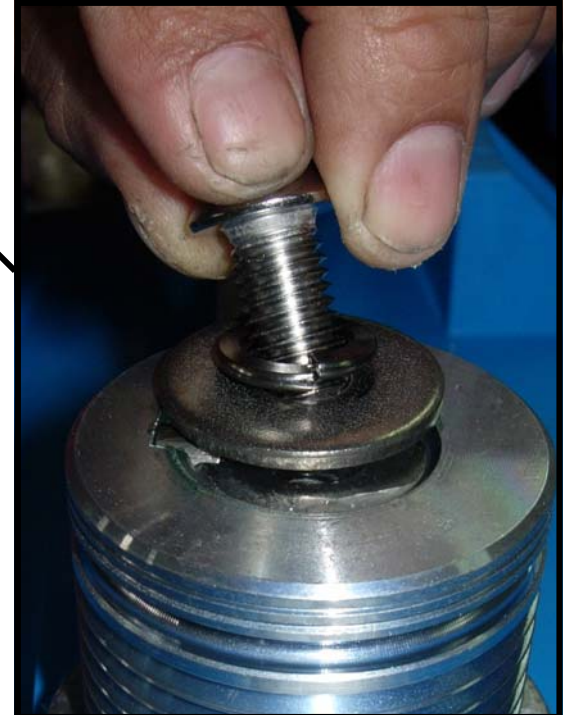
3. The Keyway, small pulley and main-shaft assembly. To finish, reinstall the washer, spring washer and tank shaft bolt
