# LINKAGE SYSTEM TECHNICAL CERTIFICATION TRAINING

Field Engineering | 2010

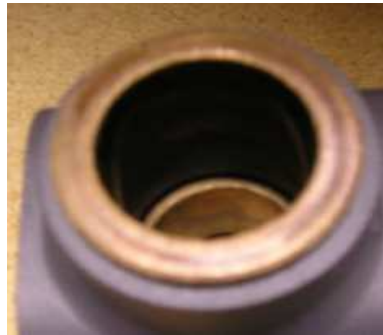
Oil Lite – Lubricates as it heats up and retains oil when it cools, use a 30 wt non-detergent oil to keep lubricated

**DO NOT USE GREASE!**

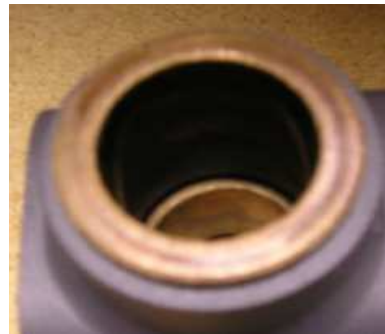
Oil Lite – Lubricates as it heats up and retains oil when it cools, use a 30 wt non-detergent oil to keep lubricated

**DO NOT USE GREASE!**

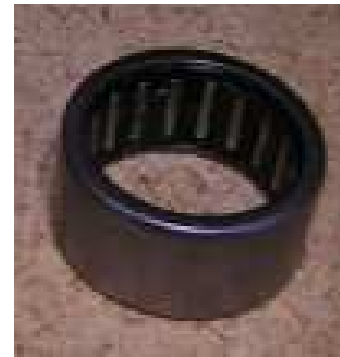
Needle Bearings - the housing does not move but the needles/rollers spin inside. Always apply press to wording/pn side.

**Add “bearing grease” since the bearing is “open”.**

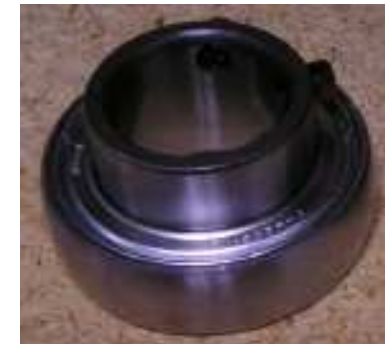
Flanged Sealed Bearing - stays secure to the shaft causing the bearing to only rotate

**No need to add grease: “Greased for Life”**

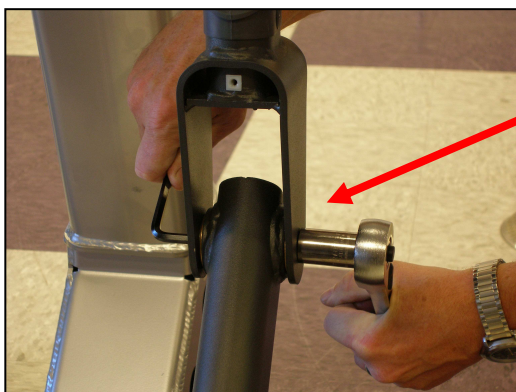
# Front Rocker Arms Removal

- » Remove and save the e-ring securing the **Rocker Arm** to the dead shaft.
- » Remove the rocker arm and save needle bearing and washers on the outside edge of the rocker arm bushing to use with the new rocker arm.
- » **Note:** There is a thrust washer and hardened washer on both sides of the pedal lever shaft.
- » **Note:** their orientation for correct installation of the new rocker arm. See next slide.

Remove and save the 6mm Allen bolt and 17mm nut securing the pedal lever to the rocker arm.

**Tools required:** 6mm Allen wrench, E-ring tool, 17mm Socket

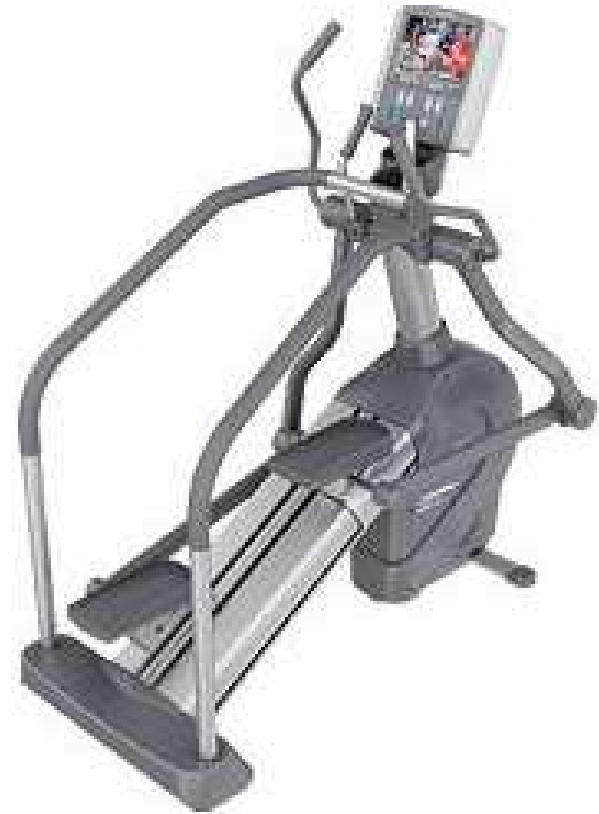
# Theory of Operation

- » The left and right pedals are connected to one another through the use of a timing belt (HTD profile).
- » When the user pedals, the timing belt engages the one-way clutch pulleys thus spinning the crank pulley.
- » The pedals are connected to control links that then oscillate the front rockers.
- » Stride length is user defined up to 26".
- » Minimum step-up = 5.5" to rear step.

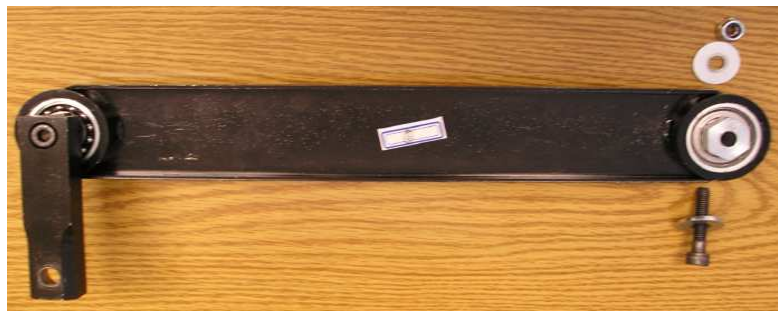
# CLSXH - New Control Link Assembly

New control link assembly – PN: GK62-00002-0071

6mm Allen  
bolt  
+ washers

spacer

washers

Nylon  
Lock nut

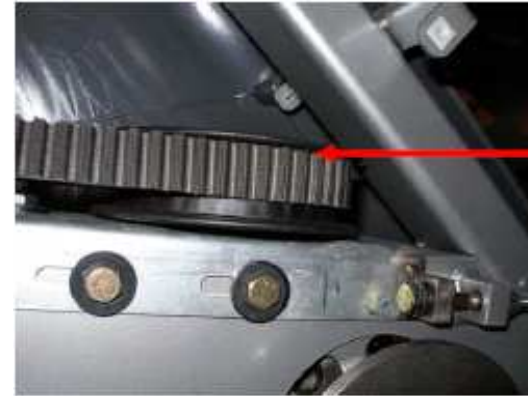
# Summit Trainer Squeaking Noise

- » Issue:
  - ◆ Squeaking noise
- » Probable cause:
  - ◆ Belt running up on pulley edge causing a squeaking noise
- » Solution:
  - ◆ Install a washer in between pulley and frame to change pulley angle
  - ◆ Confirm proper belt placement.

**Note belt location**

**Tension pulley**
