| | Troubleshooting Guide:<br>“No Console” Error | |
| Prepared by:<br>Regina Templeton | Date Prepared:<br>3/2/2015 | Models Affected:<br>AFG 7.3AIC, Horizon Elite IC7 |

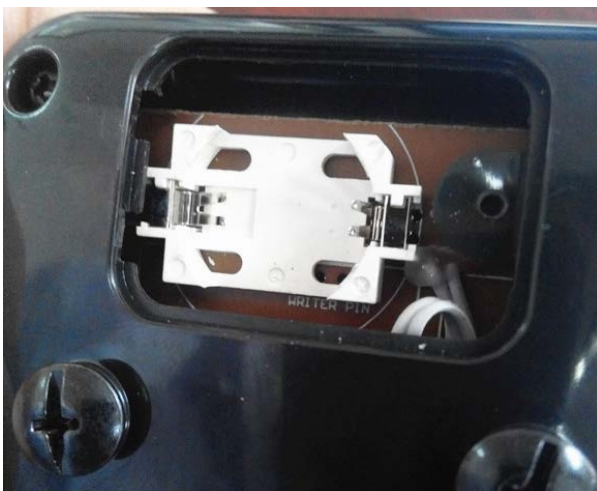
Old

The console battery compartment is redesigned. The production serial number breaks are shown below:

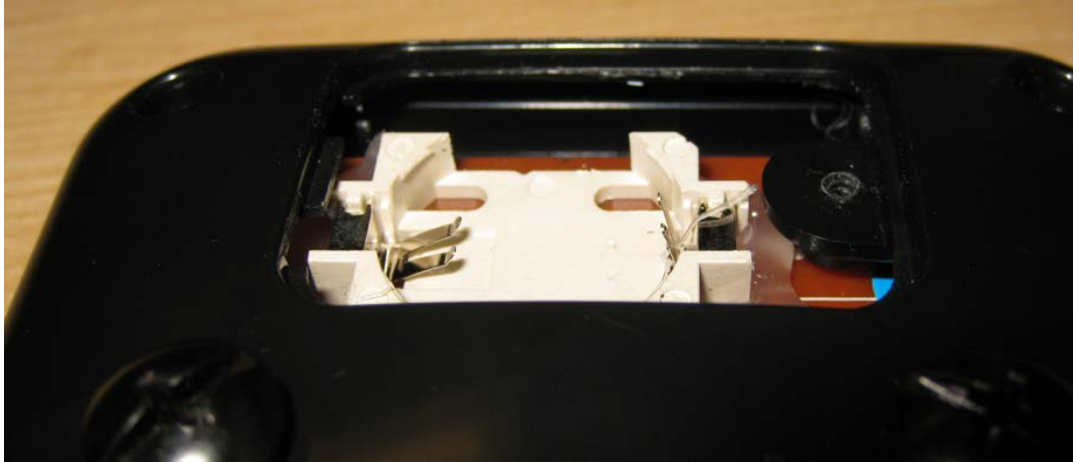
2. Bend the positive (+) pins up on the right side (beside the hole for the compartment cover screw), as shown below.

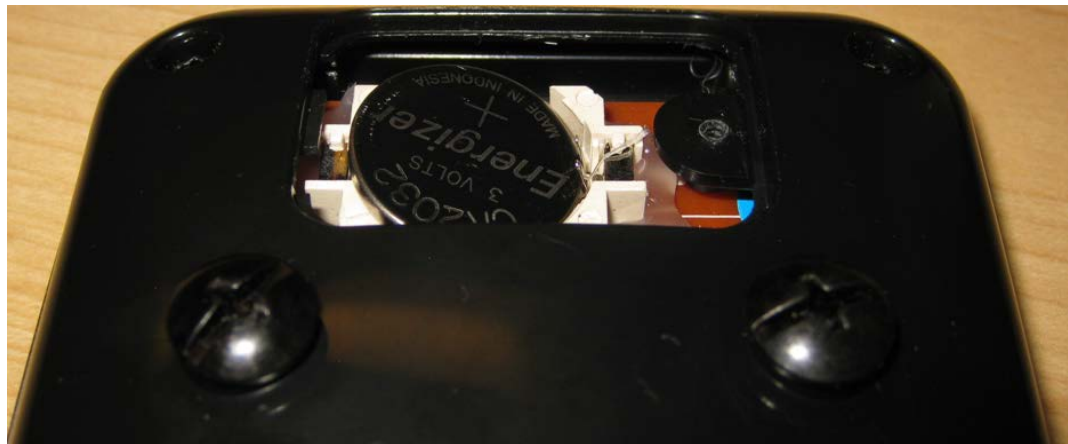
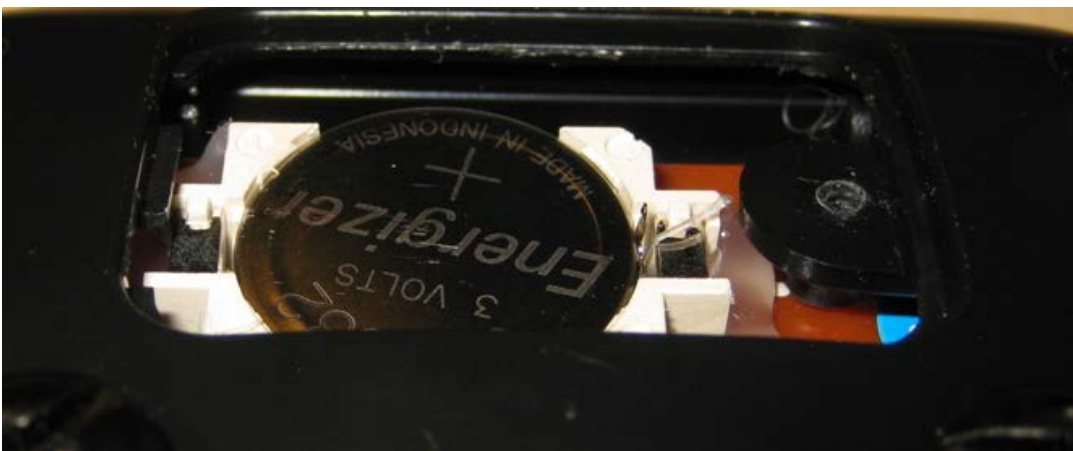
3. Insert the battery at an angle with the positive (+) side facing up. Make sure to keep the positive (+) pins upright as shown below.
