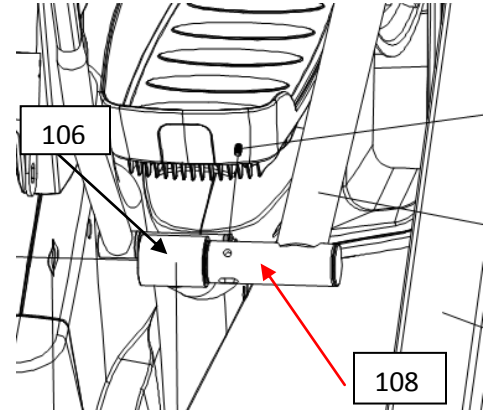
2. Ensure that the 505 bolt that secures the 106 to the 108 is fully tightened. There should be no gap between the 106 and 108 after installing the 505 bolt (step 4 of manual). Make sure to loosen the 516 set screw that is in the top of the 108 before attempting to tighten the 505. If 108 is not tapped fully this can cause a clicking/knocking sound as the bolt cannot be fully secured.

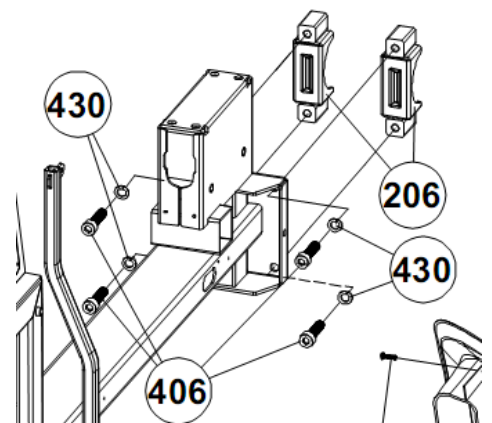
3. **Captiva Only** - If there is excessive movement in the incline frame and upright. Remove plastic covers in step 3. Ensure that bolts 406 are fully tightened.

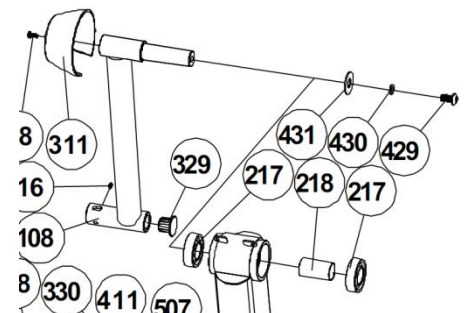
4. If clicking noise is coming from top of incline frame. Remove plastic covers then loosen bolt 429 by a ¼ turn.

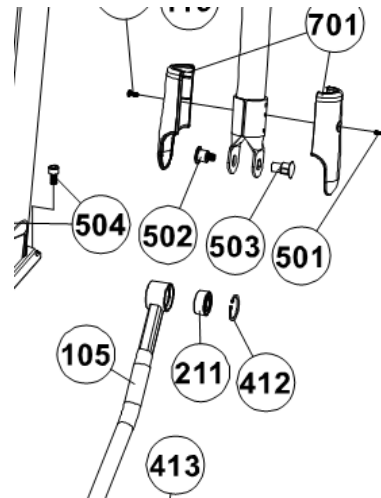
5. Check the 502 and 503 bolts. They should be snug but not loose or over tightened.

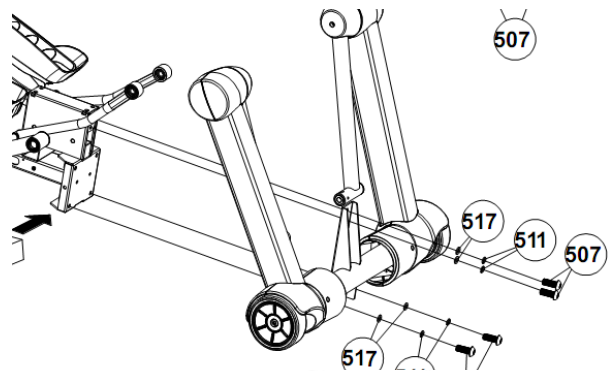
6. **Sanibel Only** – Remove the 703 front end cover. Ensure that the 507 bolts are fully tightened.

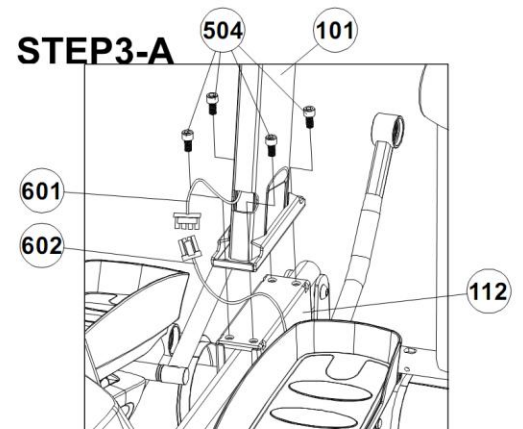
7. Re-check step 3-A and make sure the four 504 bolts are fully tightened. There should be no excessive movement from the upright.

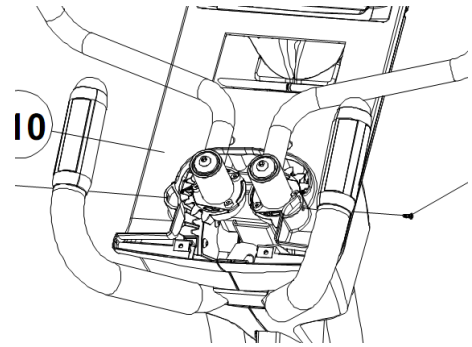
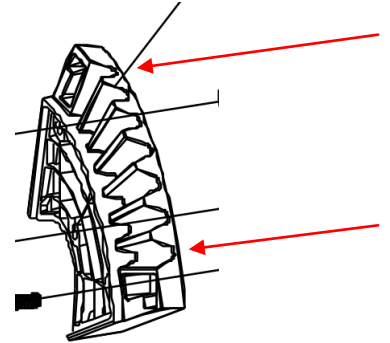
8. Clicking sound from console – Remove button panel/ipod dock. Listen to hear which side the noise is coming from. Apply white lithium grease to the gear focusing on the top and bottom grooves of the black gear (red arrows).
