| | Troubleshooting Guide:<br>Noise | | |
| Prepared by:<br>IPO Customer Service | Date Prepared:<br>4/9/2020 | Models Affected:<br>IC7.9 (FC062) | Bulletin Number:<br>NB-2004011 |

Use this guide to troubleshoot a noise issue on an IC7.9 indoor cycle.

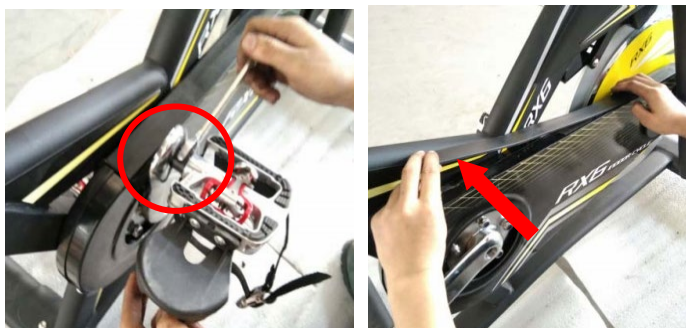
- a. Remove both pedals using a 15mm wrench. Pull the top strip off the chain cover.

**Note:** Turn counterclockwise to loosen the right pedal and clockwise to loosen the left pedal.

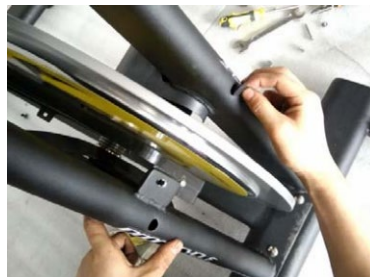
- e. Remove the two end caps from the front fork tube.

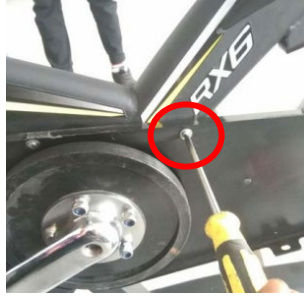
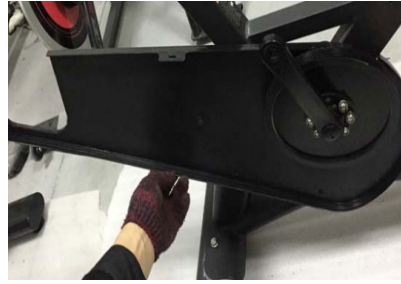
- f. Use a Phillips screwdriver to loosen the back chain guard and move the cover into the position shown below.

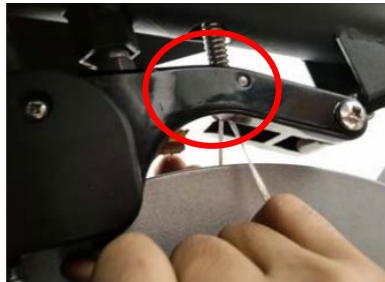
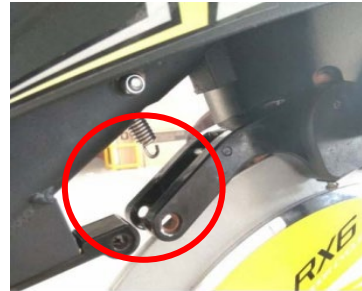
- g. Thread a rope or wire through the bottom of spring. Pull to detach the spring.

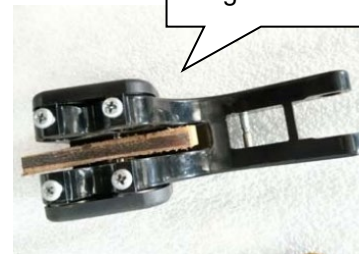
- h. Use a Phillips screwdriver and 13-15mm wrench to detach the magnet holder.

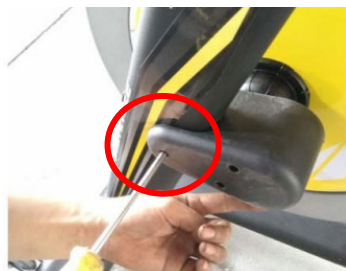
- i. Remove the decorative cover from the left side of the flywheel.

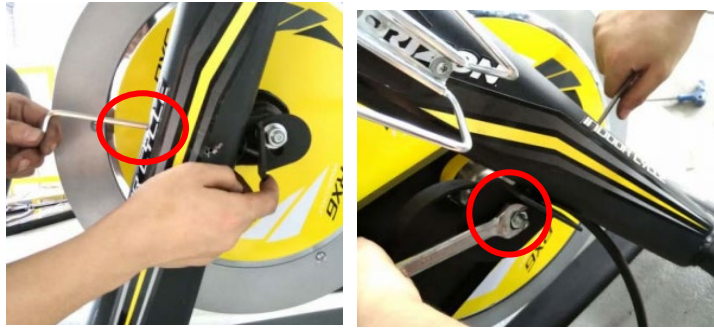
- j. Use an M5 Allen wrench and wrench to remove the flywheel. (Turn the bolt counterclockwise.)

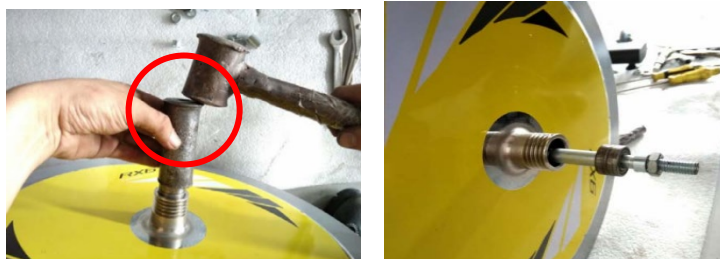
- l. Use a hammer to gently tap the hub axle until it comes out of the flywheel. Then, use the hammer to knock out the bearing on other side.

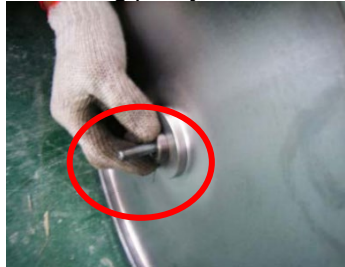
- n. Insert the hub axle and bearing. Remember to gently tap the bearing to set it in place. Insert the tube and nuts.

**Note:** The short tube is on the side of big pulley. The taller tube is on the other side.

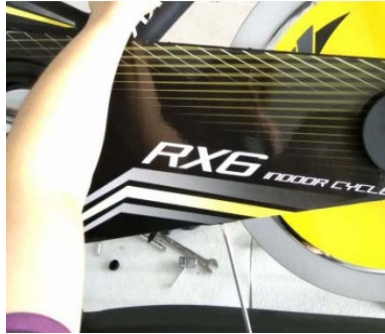
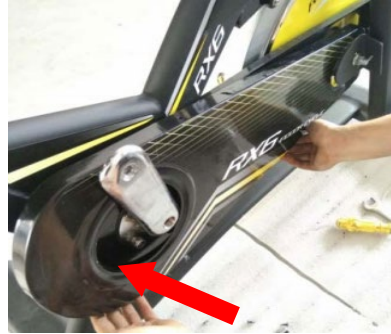
- b. Remove the three bolts that hold on the chain guard. Take the outer chain guard off the bike.

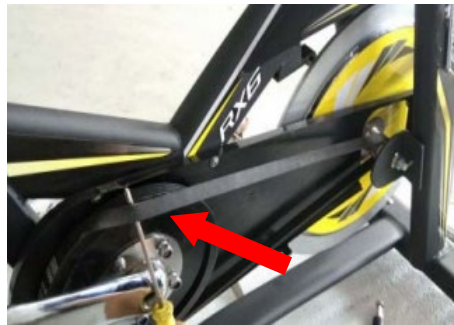
- c. Take the drive belt off of the large pulley: Insert a screwdriver in between the belt and the pulley. Use your right hand to turn the flywheel counterclockwise; as the wheel turns, use the screwdriver to guide the belt off of the pulley.

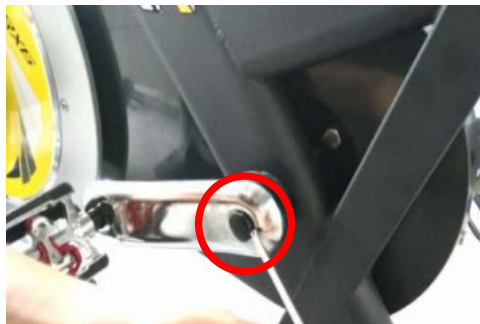
- d. Insert a flathead screwdriver between the crank cap and the crank. Turn the screwdriver counterclockwise to remove the crank cap. (Repeat this on both sides.)

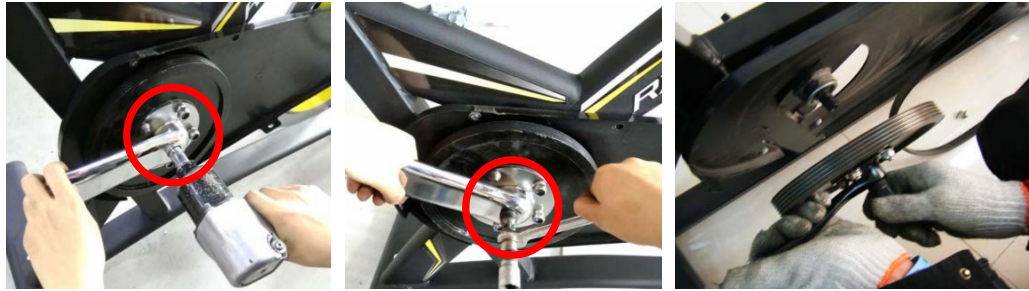
- e. Remove the screw in the crank using a 14mm socket wrench. Next, use a 22mm crank puller to remove the crank.

**Note:** Apply anaerobic adhesive on the thread of crank screw during reassembly.

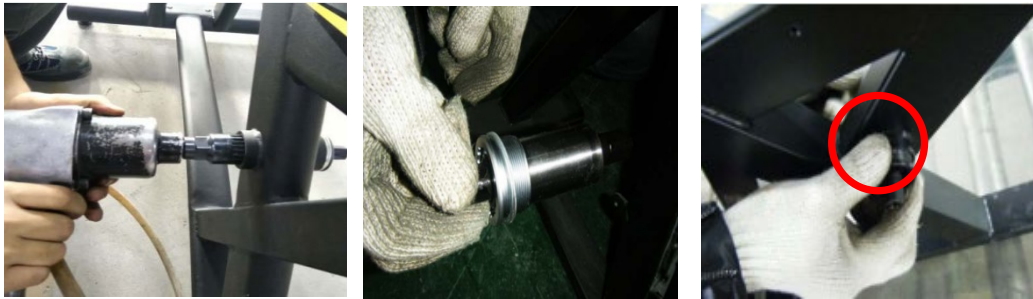
- f. Use the bottom bracket tool to remove the bottom bracket.

**Note:** Turn counterclockwise to loosen the bottom bracket. If the bottom bracket does not loosen, it might be helpful to use a hair dryer to heat the bottom bracket to about 40° C/104° F.

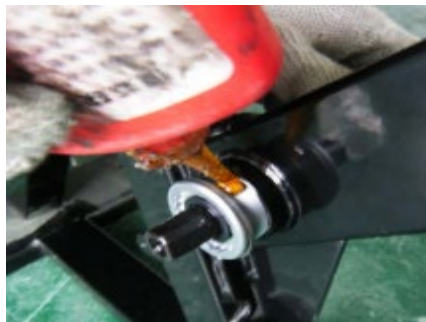
- g. Reverse these steps to reassemble the indoor cycle.

**Note:** Apply anaerobic adhesive on thread of the bottom bracket once reassembled.
