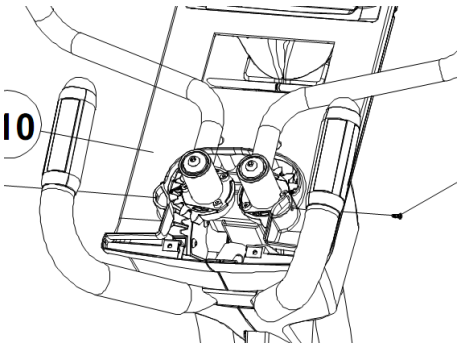
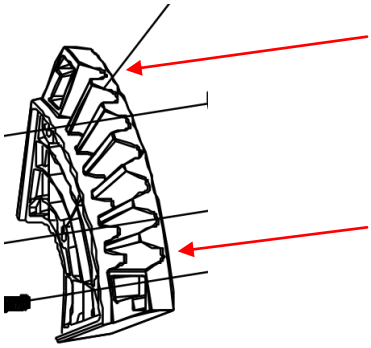
8. Clicking sound from console – Remove button panel/ipod dock. Listen to hear which side the noise is coming from. Apply white lithium grease to the gear focusing on the top and bottom grooves of the black gear (red arrows).
