| <b>MATRIX</b> | Troubleshooting Guide:<br>Quick Keys | |
| Prepared by:<br>Emilie McWilliams,<br>Allan Orlofske, Whitney Wells | Date Prepared:<br>3/1/2018 | Models Affected:<br>Matrix Retail ascent trainers,<br>ellipticals, bikes, and treadmills |

Use this guide for help troubleshooting when the incline, resistance, and/or speed keypad toggles on the hand grips (ascent trainers, bikes, or ellipticals) or console base set (treadmills) do not make the correct adjustments (no response, increases instead of decrease, resistance changes when incline buttons pressed, etc.).

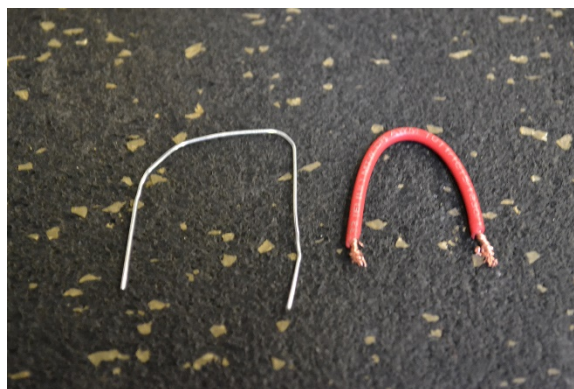
**Option 2** – Use a small, conductive piece of metal (for example, a paper clip or a segment of wire) to test each wire along the path to the console.

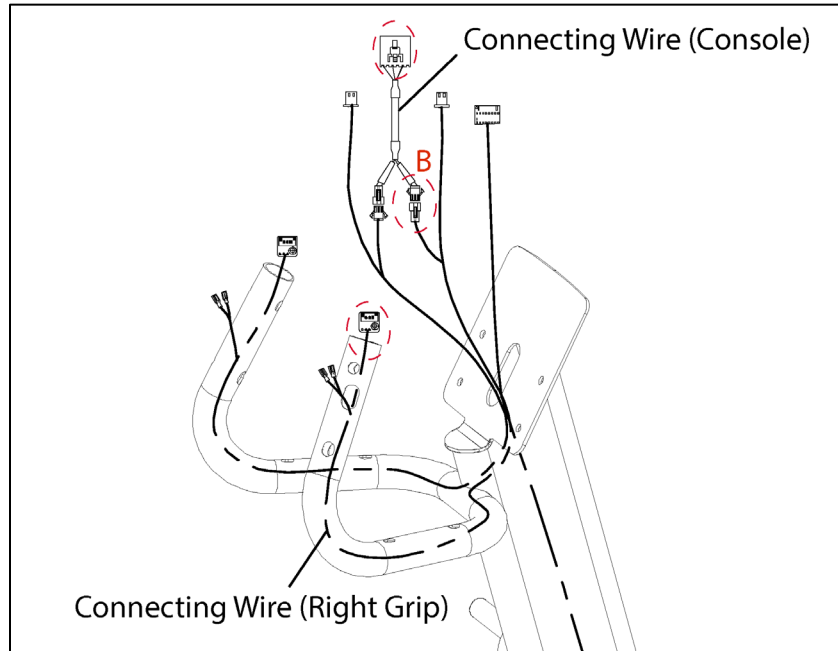
E30 Wiring Path (Right Side):

- a. Unplug the keypad wire (on the grip) from the Connecting Wire (Right Grip). Use the piece of metal to touch the two outer pins on the connecting wire's connector (the middle pin is a ground wire)

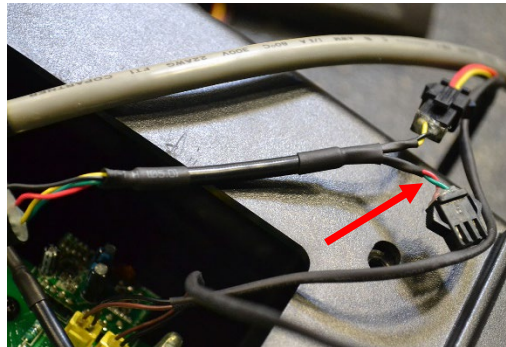
- i. Note the color of the wires leading to the plug that attaches to the Console Wire (Right Grip). (This plug is labeled “B” in the diagram on page 4.) In the example below, the wires are red and green.

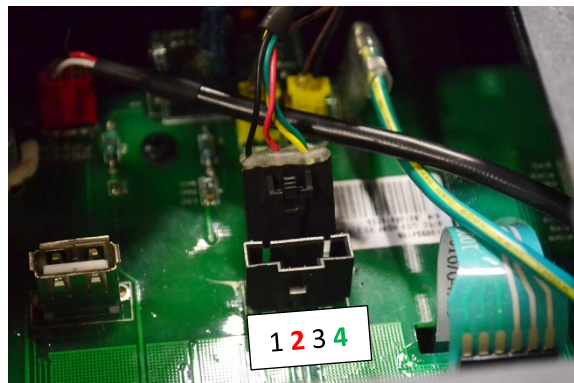
- ii. Next, note which pins the wires line up with on the board. In the example below, the red wire goes to the second pin, and the green wire goes to the fourth pin.

- iii. Use the metal piece to touch the two pins you identified on the board in the previous step.
  - If the console beeps and resistance increases or decreases by one level, you have isolated the issue to the Connecting Wire (Console). Replace the wire.
  - If the console does not beep and resistance does not change, replace the console.
- 3. 50 series ascent trainers only: If the resistance keypad still does not respond, remove the covers on the right side.
