| MATRIX | | Service Bulletin | |
| | | Matrix 2016 7xi/7xe and T130xi Console Troubleshooting | |
| Effective Date: Dec. 20, 2016 | Models Affected:<br>7xe-05-C (EP620, TM527); 7xi-03-C (EP621, TM528);<br>T130xi (TM541) | Bulletin Num.<br>NB-1701007<br>ver.10 | |

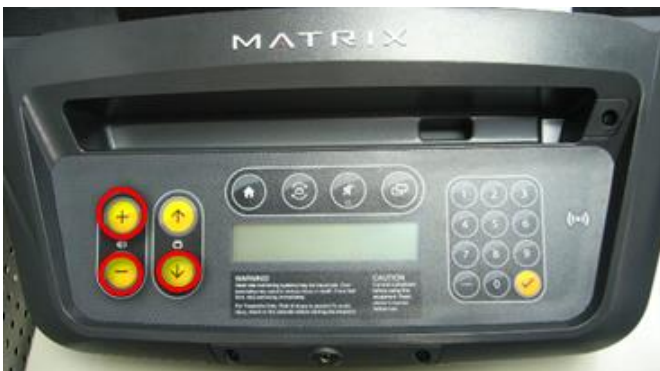
Solution 1 - Recovery UCB software

➤ **Console always frozen at the Johnson triangle logo**

Press and hold **VOLUME UP**, **VOLUME DOWN** and **CHANNEL DOWN** keys for 5 seconds to start recovery software. When recovery software is complete, machine automatically returns to the home display.

P.S. If the recovery UCB software fails (the console doesn't come back to welcome screen), please try to run the recovery again. If it still does not work, please return the damaged UCB to JHT.

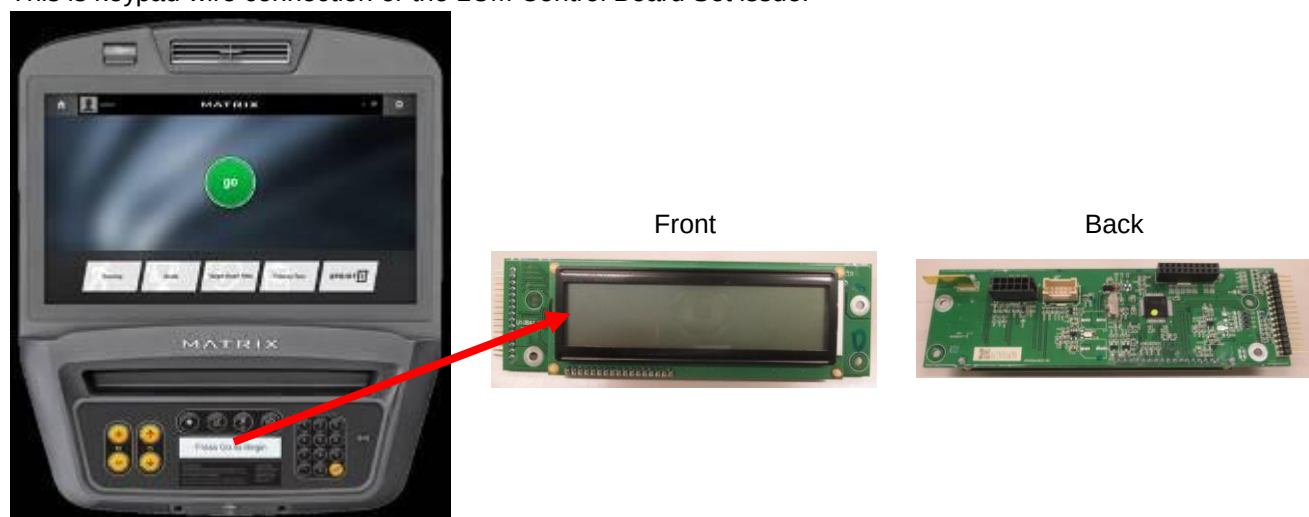
This is keypad wire connection or the LCM Control Board Set issue.

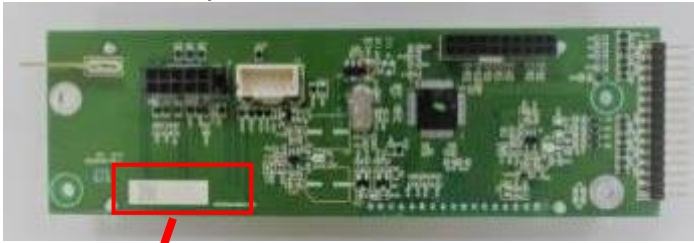
## Solution 4- Replace LCM

Started S/N:

e.g. 17 (2017), 22 (week), 106779 (lot no.)

1. Replace the LCM Control Board Set. JHT has improved the LCM Control Board Set.
2. The major change components are TVS diodes VZ1~VZ9, VZ10~VZ29, VZ36 and VZ37.
3. The starting S/N of new LCM Control Board Set is **1738102197**.
4. The new application starts from November, 2017 (plan).
