## Most Common Error Codes Guide

### Embedded Touch Screens

This guide contains troubleshooting for the most common error codes that may occur on an embedded touch screen.

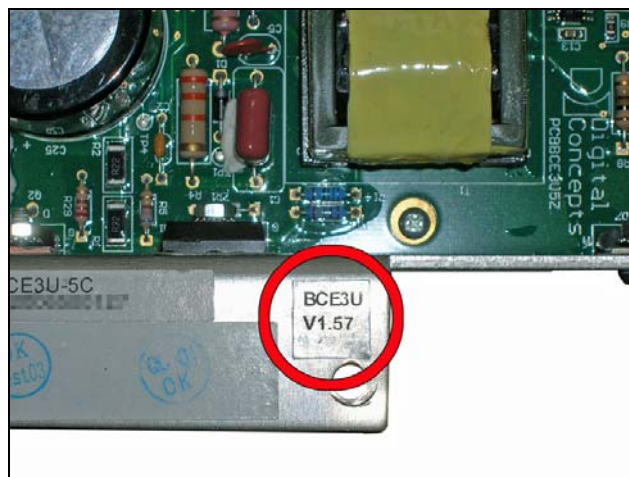
Fig. 3

1. Remove the LCB from the unit.
2. There is a label on each LCB that identifies what version software it contains.
3. The software must be at least version 1.57 or higher. If the software is before 1.57, replace the LCB.

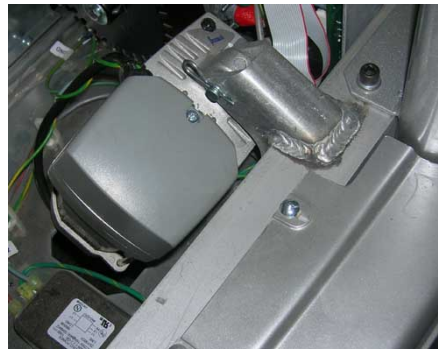
Fig. 1

1. Turn off the treadmill and remove the motor shroud so the elevation motor is visible (Fig. 1)

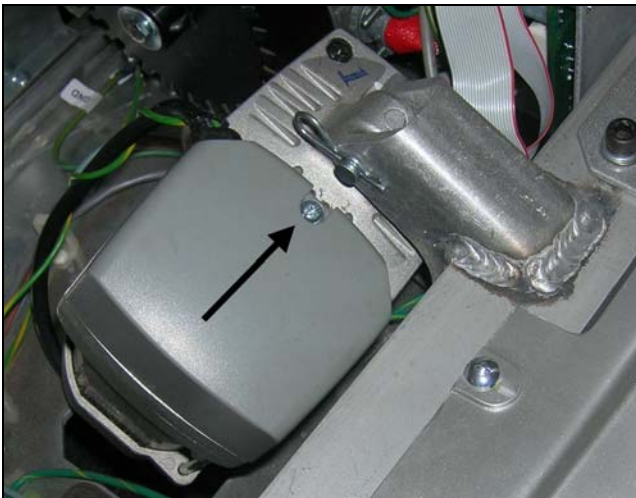
Fig. 2

2. Remove the screw (Fig. 2) holding the cap to the motor and remove the cap to expose the elevation potentiometer (pot) (Fig. 3).

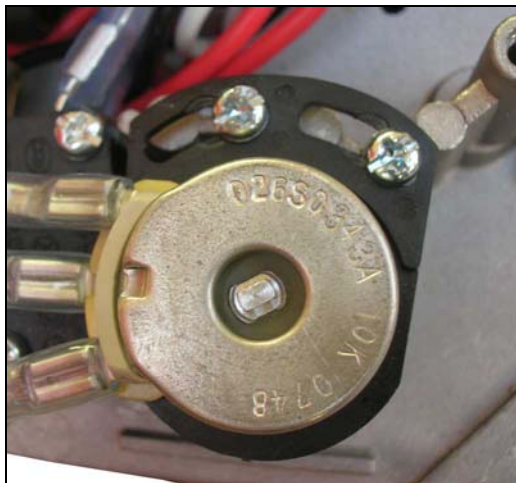
Fig 5

- If the unit is at max elevation, turn the pot counter-clockwise until the screws are completely to the right side of the pot slots (Fig. 5). Tighten the screws.
- If the unit is stuck at 0% elevation, turn the pot clockwise until the screw are completely to the left side of the pot slots (Fig. 6). Tighten the screws.

- If the unit is at the max elevation, the value must be between 500-600 ohms.
- If the unit is at 0%, the value must be between 9.4 – 9.5 k ohms.

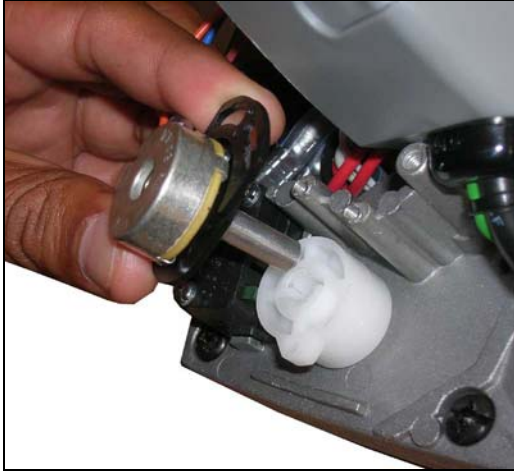
Fig. 7

6. Remove both screws holding the pot in place. Gently wiggle the pot to pull it out (Fig. 7). Once the pot is pulled out, gently turn the center shaft of the pot to get the desired ohm value (Fig. 8).

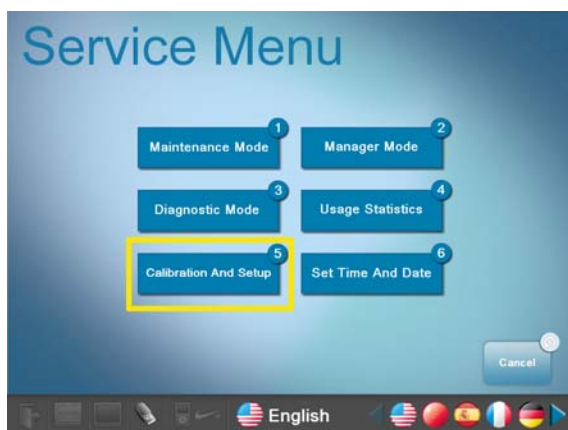
Fig. 2

2. Once in the “Service Menu” press the ‘Calibration and Setup’ (Fig.2). The display will ask for a code which is ‘2 1 8’, then press ‘OK’ on the screen (Fig. 3). Once in “Calibration and Setup”, press ‘Incline Calibration’ (Fig. 4)
