| | | Troubleshooting Guide:<br>Master Error Code List | |
| Document Number:<br>NB-1903010 | | Date Prepared:<br>3/15/16 | Models Affected: <ul style="list-style-type: none"><li>• Matrix: All</li><li>• Vision: R60-03, R70/-02, S60/-03, S70/-02/-03, U60-03, U70/-02, T600/E, SUR-600E</li><li>• Massage Chair: Basic Fit J6950 (05XX codes only)</li></ul> |

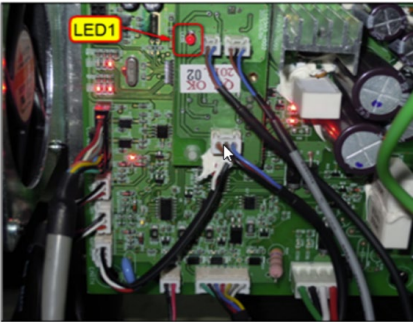
| Error Code | Description | Class Level | Troubleshooting – Level 1 (CTS) | Troubleshooting – Level 2 (Technician in the Field) |
|---|---|---|---|---|
| 02C7 | The receiver is disconnected for climbmill frame IR sensor | C | a. Check the connection of the frame IR receiver cable from the LCB to the frame IR receiver sensor.<br>b. Replace the frame IR receiver cable. | Check the connection of the frame IR receiver cable from the LCB to the frame IR receiver sensor.<br>Replace the LCB set or the frame IR receiver cable.<br><br>CS17—CS24 ClimbMills:<br>a. Verify that LED1 on the daughter board of the LCB is lit and flashing.<br> i. If LED1 is <b>not</b> lit and flashing, replace the daughter board. Verify that the red/blue and red/black/blue wires are properly connected to the daughter board as shown above. Fix wire connections if necessary.<br>ii. If LED1 <b>is</b> lit and flashing, replace the IR sensor set, the transmitter board, and the receiver board. |
