**NAUTILUS** Service Manual  
*TreadClimber®*, Model TC916  
*Commercial Series*

**FOR DETAILED INSTRUCTIONS AND INFORMATION ON ASSEMBLY AND USE FOR THE NAUTILUS® COMMERCIAL SERIES TREADCLIMBER®, MODEL TC916, REFER TO THE ASSEMBLY AND OWNER'S MANUALS.**

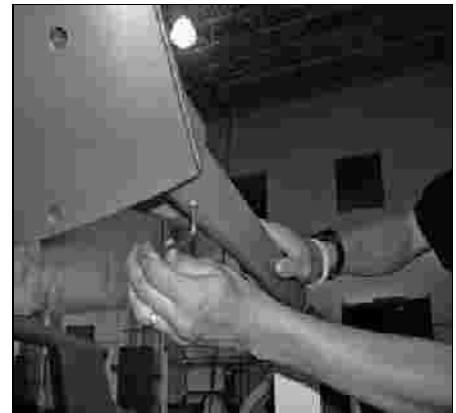
**Figure 1-1**

**NOTE:** *To replace console, reverse instructions.*

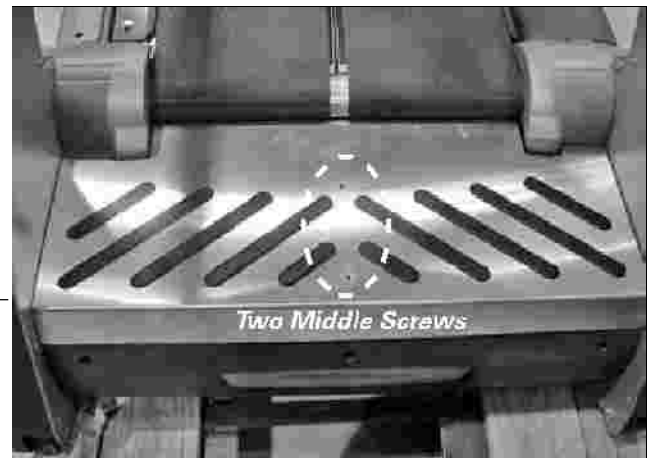
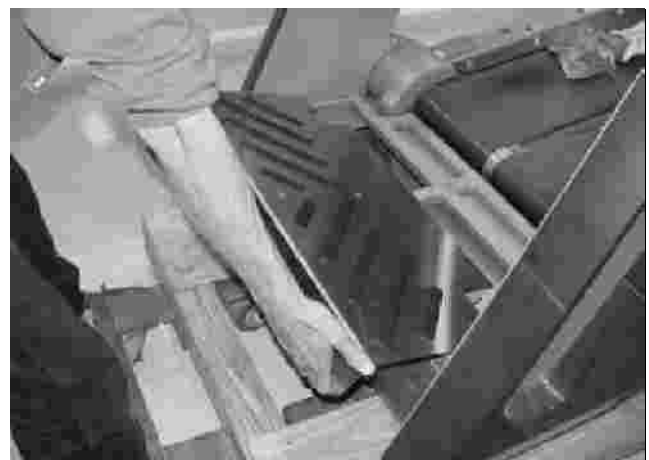
- 3-1:** Unplug the unit from the power source and ensure that all power has been drained from the unit.
- 3-2:** Remove two (2) middle screws from Rear Step Cover (see Figure 3-1).
- 3-4:** Lift and slide step cover plate back to remove (see Figure 3-2).
- 3-3:** Remove four (4) screws from Step Weldment (see Figure 3-3).
- 3-5:** Replace rear cover by sliding back into place and re-installing four (4) outer screws.
- 3-6:** Place Step cover onto Step weldment and reattach with two (2) screws (see Figure 3-2 and Figure 3-1).

Removing the step cover plate provides access to the I/O cables needed for the removal of the uprights.

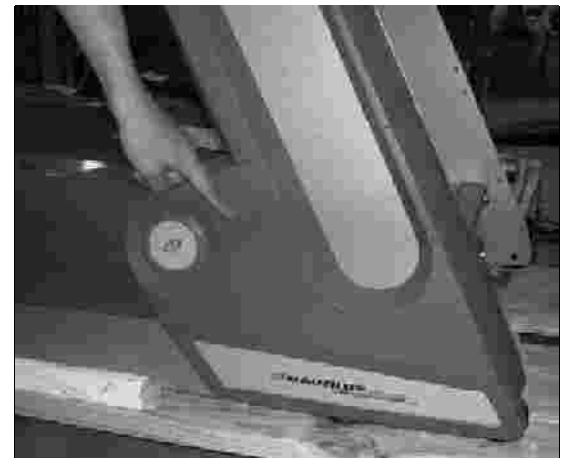
**Figure 5-6: Lower plastic parts.**

**5-5:** Remove the Right Lower Cover (P/N - SM17657) and Left Lower Cover (P/N - SM17658). See Figure 5-6 and 5-7.

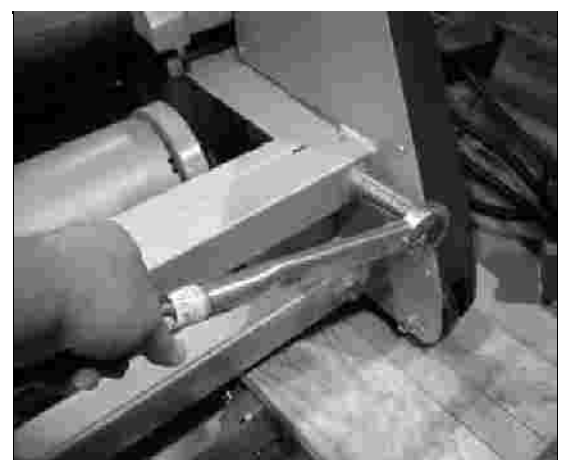
**Figure 5-8**

**5-6:** Remove four (4) upright weldment bolts (see Figure 5-8).

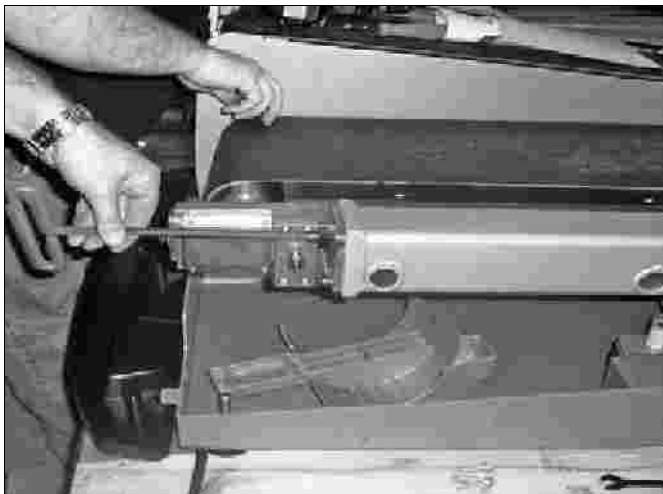
**Figure 3: Removing end casting with Allen wrench.**

- 8-6:** Relieve all tension on the belt by completely loosening the alignment screw and then the tensioning screw.
- 8-7:** Remove end casting with front roller using 5/16 Allen wrench (see Figure 3).

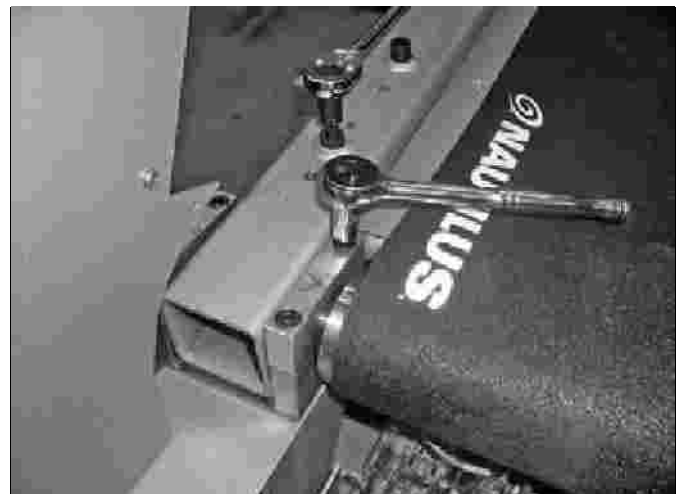
**Figure 6: Remove treadle bolts & pivot bolts; 4 bolts per side.**

- 8-11:** There are 2 treadle bolts and 4 treadle pivot bolts on each side. Remove these 6 bolts on one side, and loosen the 2 treadle bolts and remove the 4 pivot bolts using a 3/8 Allen and socket wrench (see Figure 6).

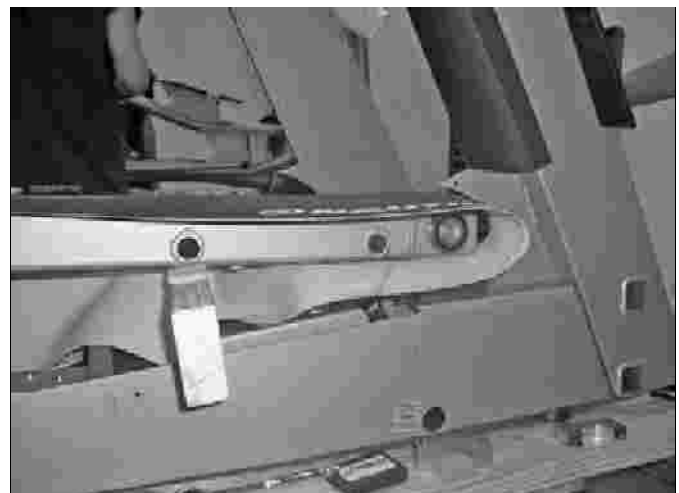
**Figure 7: Lift treadle to create clearance.**

- 8-12:** Lift treadle to create clearance for walk belt to slide between upright and end of roller (see Figure 7).
- 8-13:** Replace belt and deck using the reverse order of steps 11 through 1.

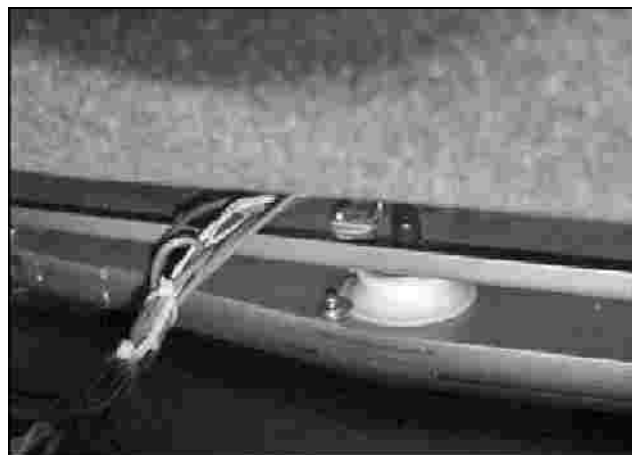
**Figure B-1**

- c) Slowly move the treadles up and down while looking at the encoder PCB mounted in the center of the dependency mechanism. There is a light on the PCB. Note the position of the treadles when the light on the PCB comes on. The treadles should be parallel within 1 inch (2.5 cm) of each other when the PCB light comes on (see Figure B-1).

- d) If the treadles are not parallel when the encoder PCB light comes on, then the large encoder wheel will need to be adjusted. Go to section C of this section in the Service Manual to re-center the encoder wheel. Be sure to verify that the large encoder wheel is firmly fixed to the dependency

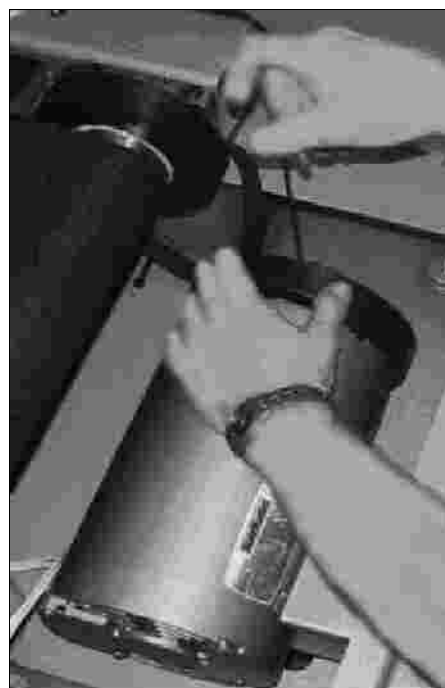
Figure 1: Flywheel set screws

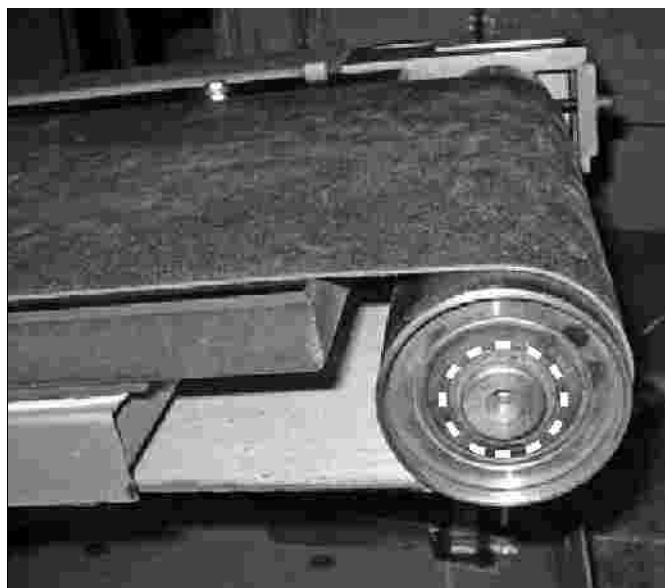
Figure 2: Front Roller Snap Ring Location

**12-6:** Verify that the snap ring on the front rollers is in place properly (see Figure 2).
