# TreadClimber™ Replacing Leeson Motor Instr. FF2856 (TO BE INCLUDED WITH PK1130 / JDE #12710)

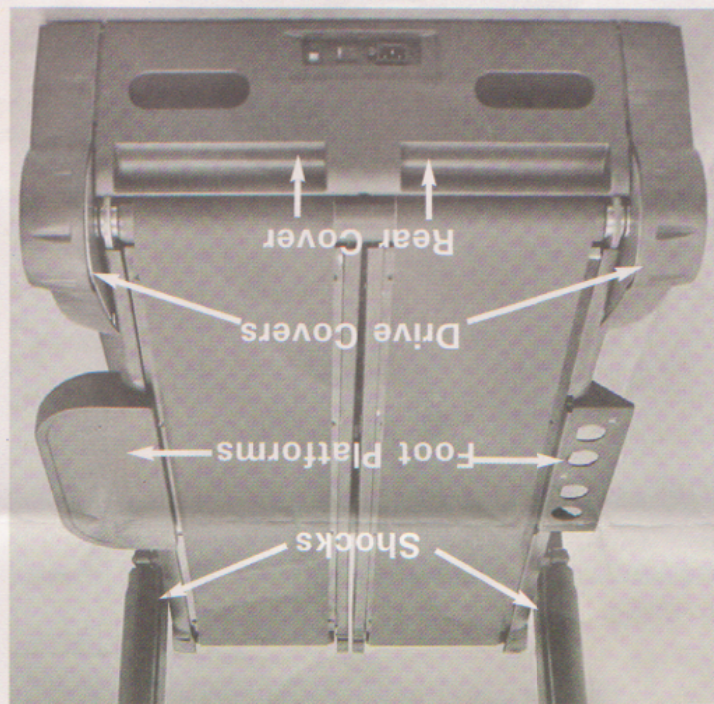
Fig. 1

Remove right and left resistance shocks (Fig.1).  
Remove right and left plastic drive covers (Fig.1).  
Remove rear cover (Fig.1).

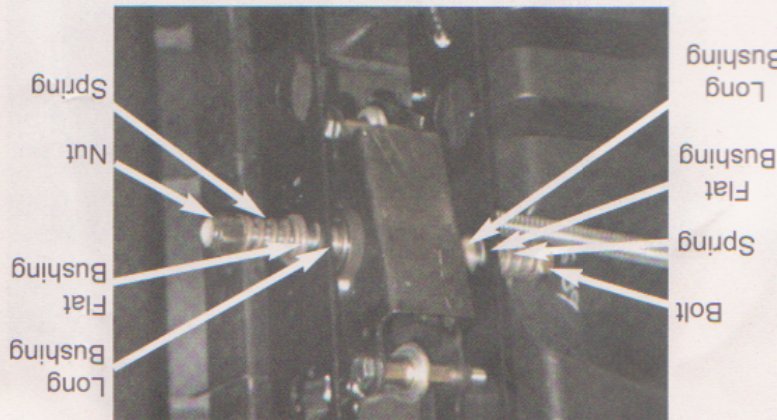
Fig. 2

(a). For **double rear roller treads** remove teeter pivot bolt assembly (nut, bolt, springs, and spacers) to detach treadle linkage from base unit (Fig.2)

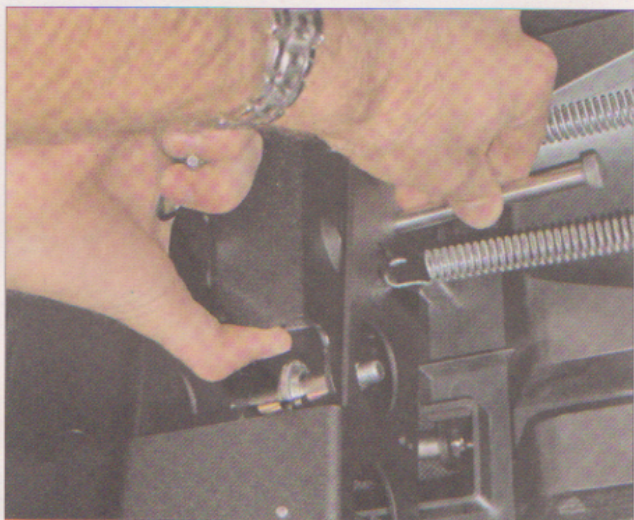
Fig. 2B

(b). For **single rear roller treads** remove the 3/8" x 3 3/4" shoulder bolt and 5/16" nylock nut attach the teeter assembly to base frame (Fig. 2A) using a 3/16" hex key and 9/16" open end wrench (Fig. 2B).
