| | Troubleshooting:<br>E2 Error | |
| Prepared by:<br>Emilie McWilliams | Date Prepared:<br>11/11/2014 | Models Affected:<br>7.3AR, 7.3AU |

The E2 error screen displays on AFG 7.3AR or 7.3AU.

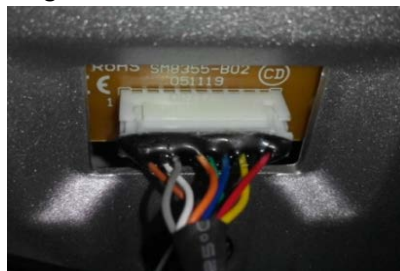
1. Remove the console. Unplug and then reconnect the console cable three or four times, then cycle power. (The E2 error may occur because the resistance motor has gotten out of range. It can move slightly when power is cycled.)
2. Unplug and then reconnect the power adapter.
3. Check the connection between the console cable and the motor. Unplug and realign the connector if necessary.
  - a. **<Figure 1>** shows a normal connection
  - b. **<Figure 2>** shows a skewed connection

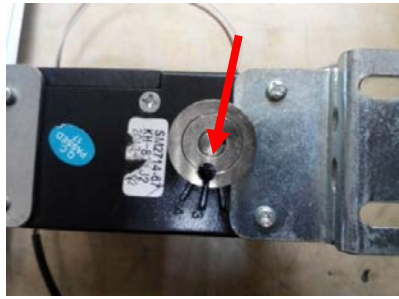
<Figure 3>

**Note:** In normal range, the notch rests between the 2 and 4 markings <Figure 3>.

5. Examine the motor. If the scale is outside the normal range, short out pins.

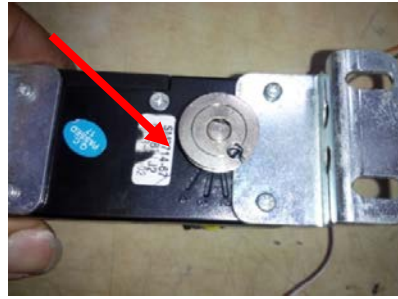
<Figure 4>

- a. If motor is within the normal range, but the error still occurs, go to Step 6.
- b. If motor is outside the normal range <Figure 4>, use a screwdriver to short out **two (2)** of the **three (3)** pins on the bottom side of the motor <Figure 5>, <Figure 6>.

6. Replace the motor, part # **1000350671**.
