| | Troubleshooting Guide:<br>No Resistance/Loose Handle | |
| Prepared by:<br>IPO Customer Service | Date Prepared:<br>1/13/2020 | Models Affected:<br>Horizon IC7.9 Indoor Cycle<br>(FC062) |

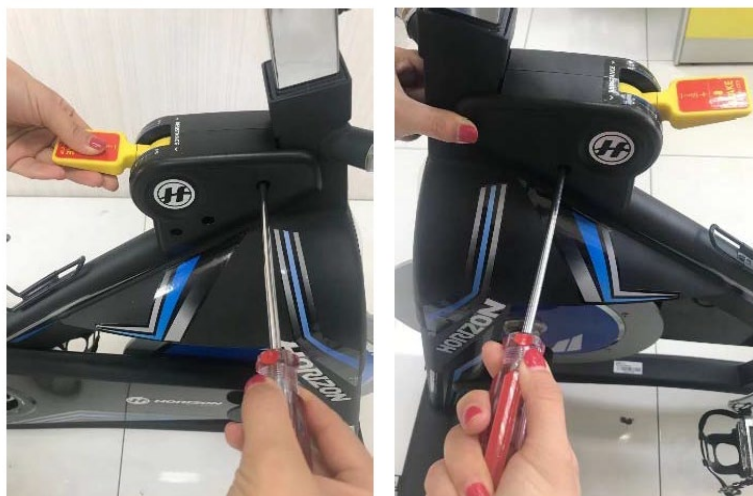
1. Use a Phillips screwdriver to remove 4 screws. Note: Turn counterclockwise to remove and clockwise to install.

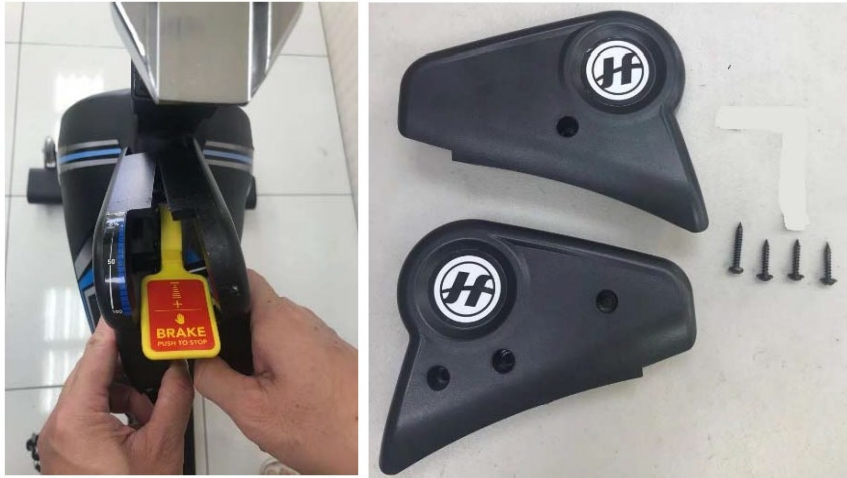
2. Next, remove the left and right brake covers.

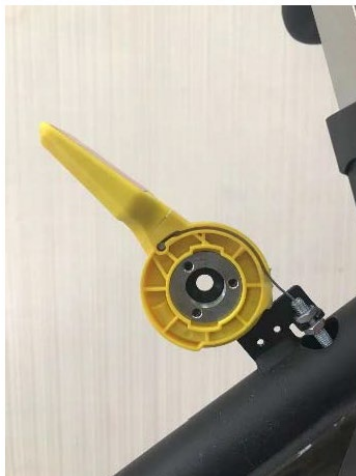
Normal

3. After removing both brake covers, examine the steel rope.
  - a. Under normal circumstances, the steel rope is inserted in the groove of the emergency handle (see photo below).
  - b. If the steel rope is out of the groove, it will influence the brake system and prevent it from functioning effectively. Continue to step 4.

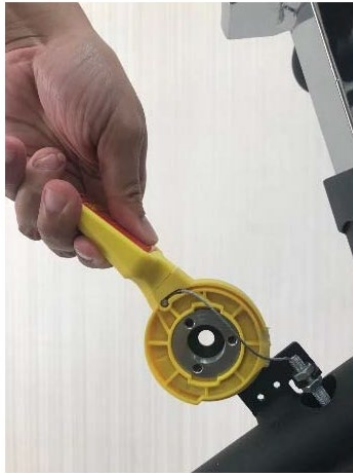
Push Handle Up

4. To fix this, please push the emergency handle up and adjust the steel rope to fit into the groove.

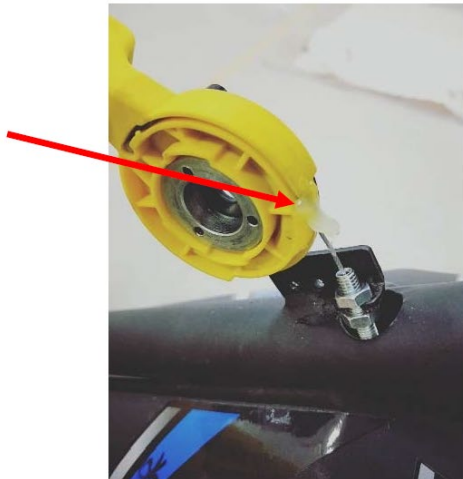
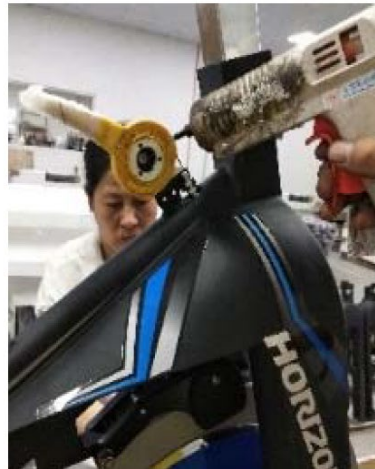
5. Finally, use a hot glue gun to attach the steel rope inside the groove, making the connection firm and durable.
