**HORIZON**  
**FITNESS**

# **TREADMILL BELT SPEED**

## **TROUBLESHOOTING GUIDE**

T101-05, T101-07, TR5, TR3 TREADMILLS

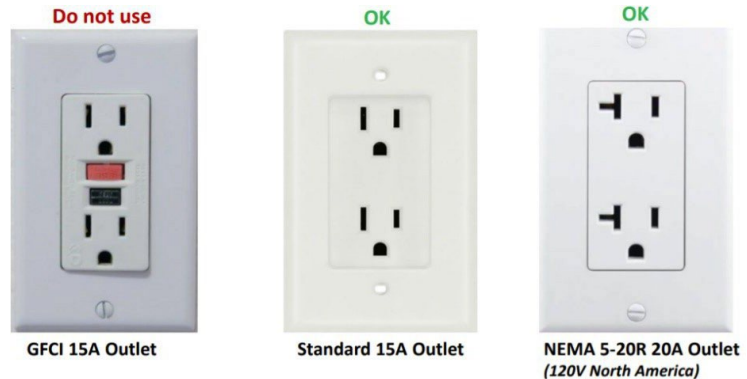
1. Check that the software is up to date. Software download files and instructions are available here: <https://support.horizonfitness.com/hc/en-us/articles/5149009125005-Software-and-Firmware-Updates>
2. The treadmill must be connected to a 'dedicated 15-amp circuit' by itself. – no other appliances or devices should be powered from the same breaker the treadmill is powered from. Confirm that the outlet is not a GFCI or AFCI outlet.

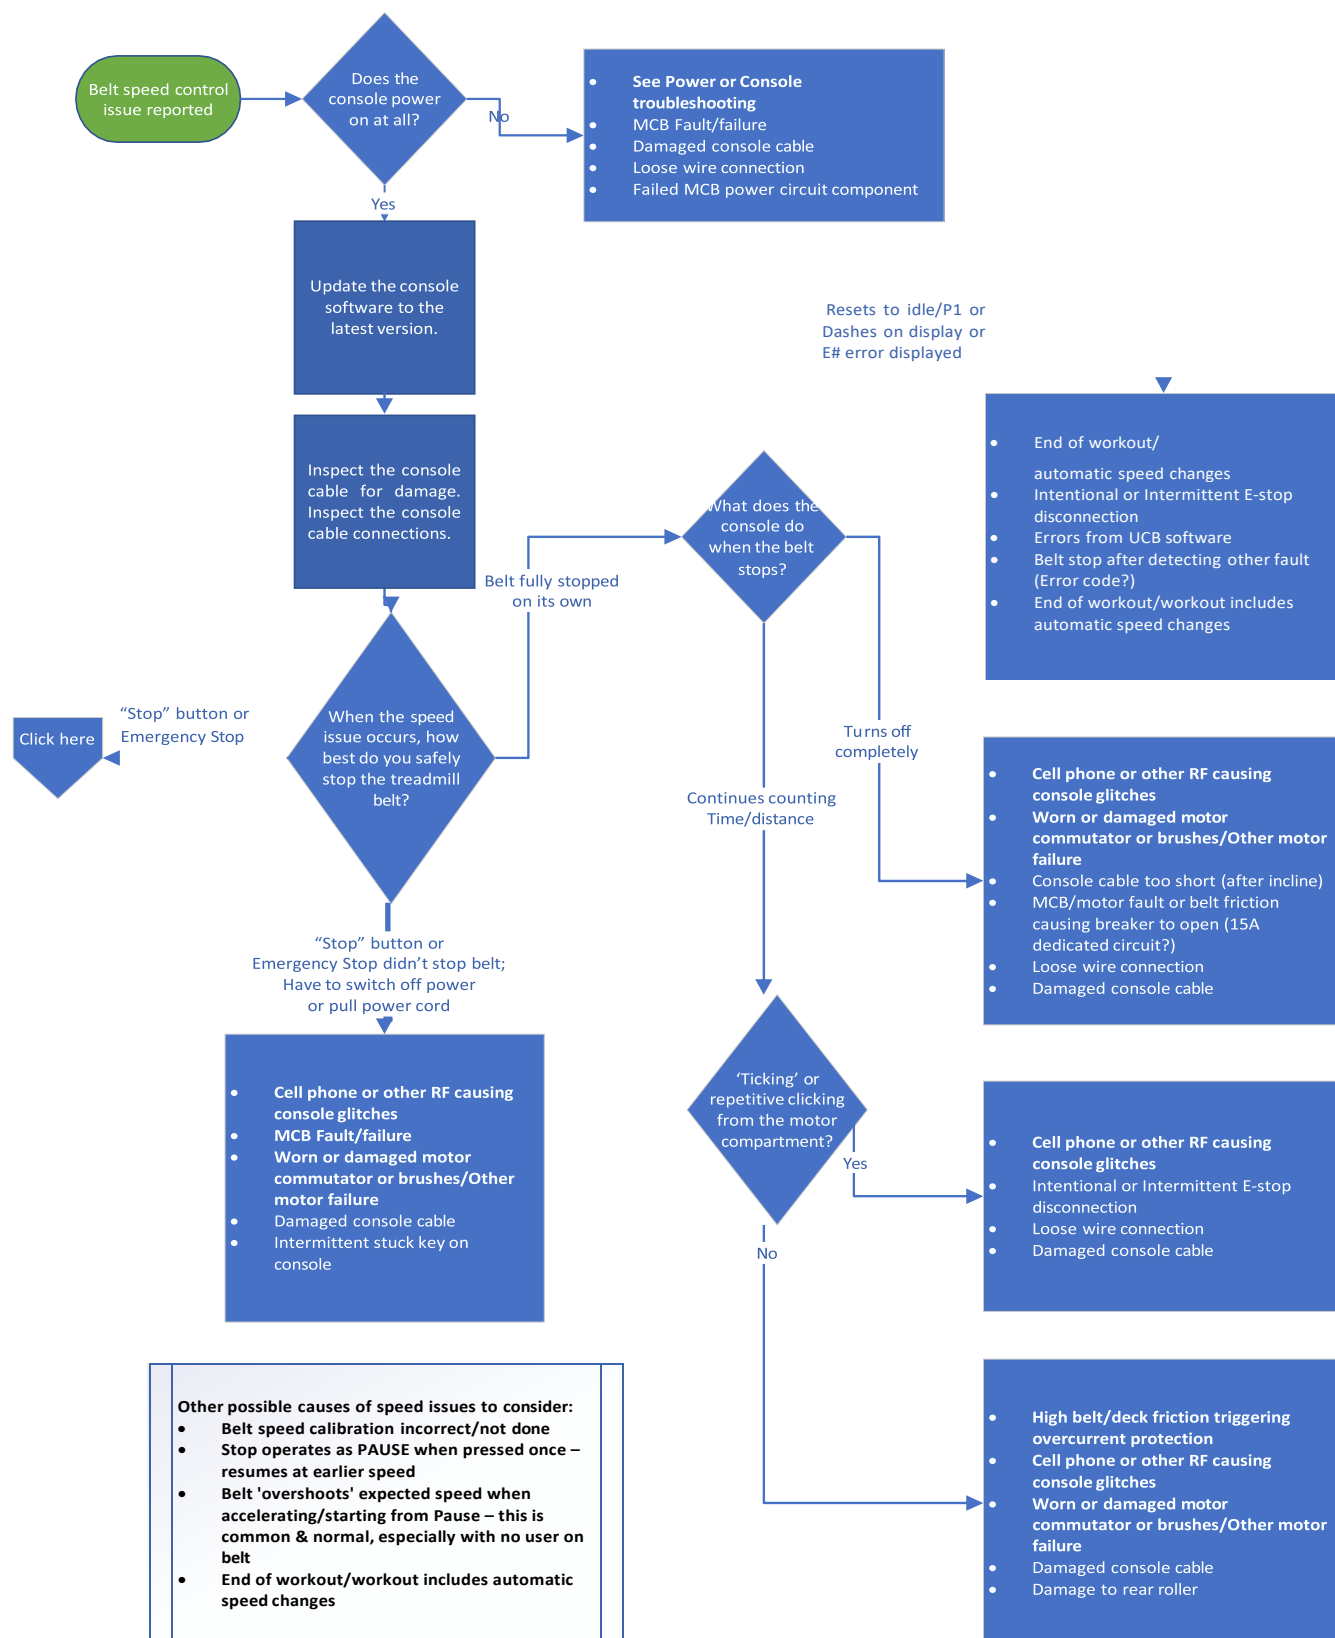
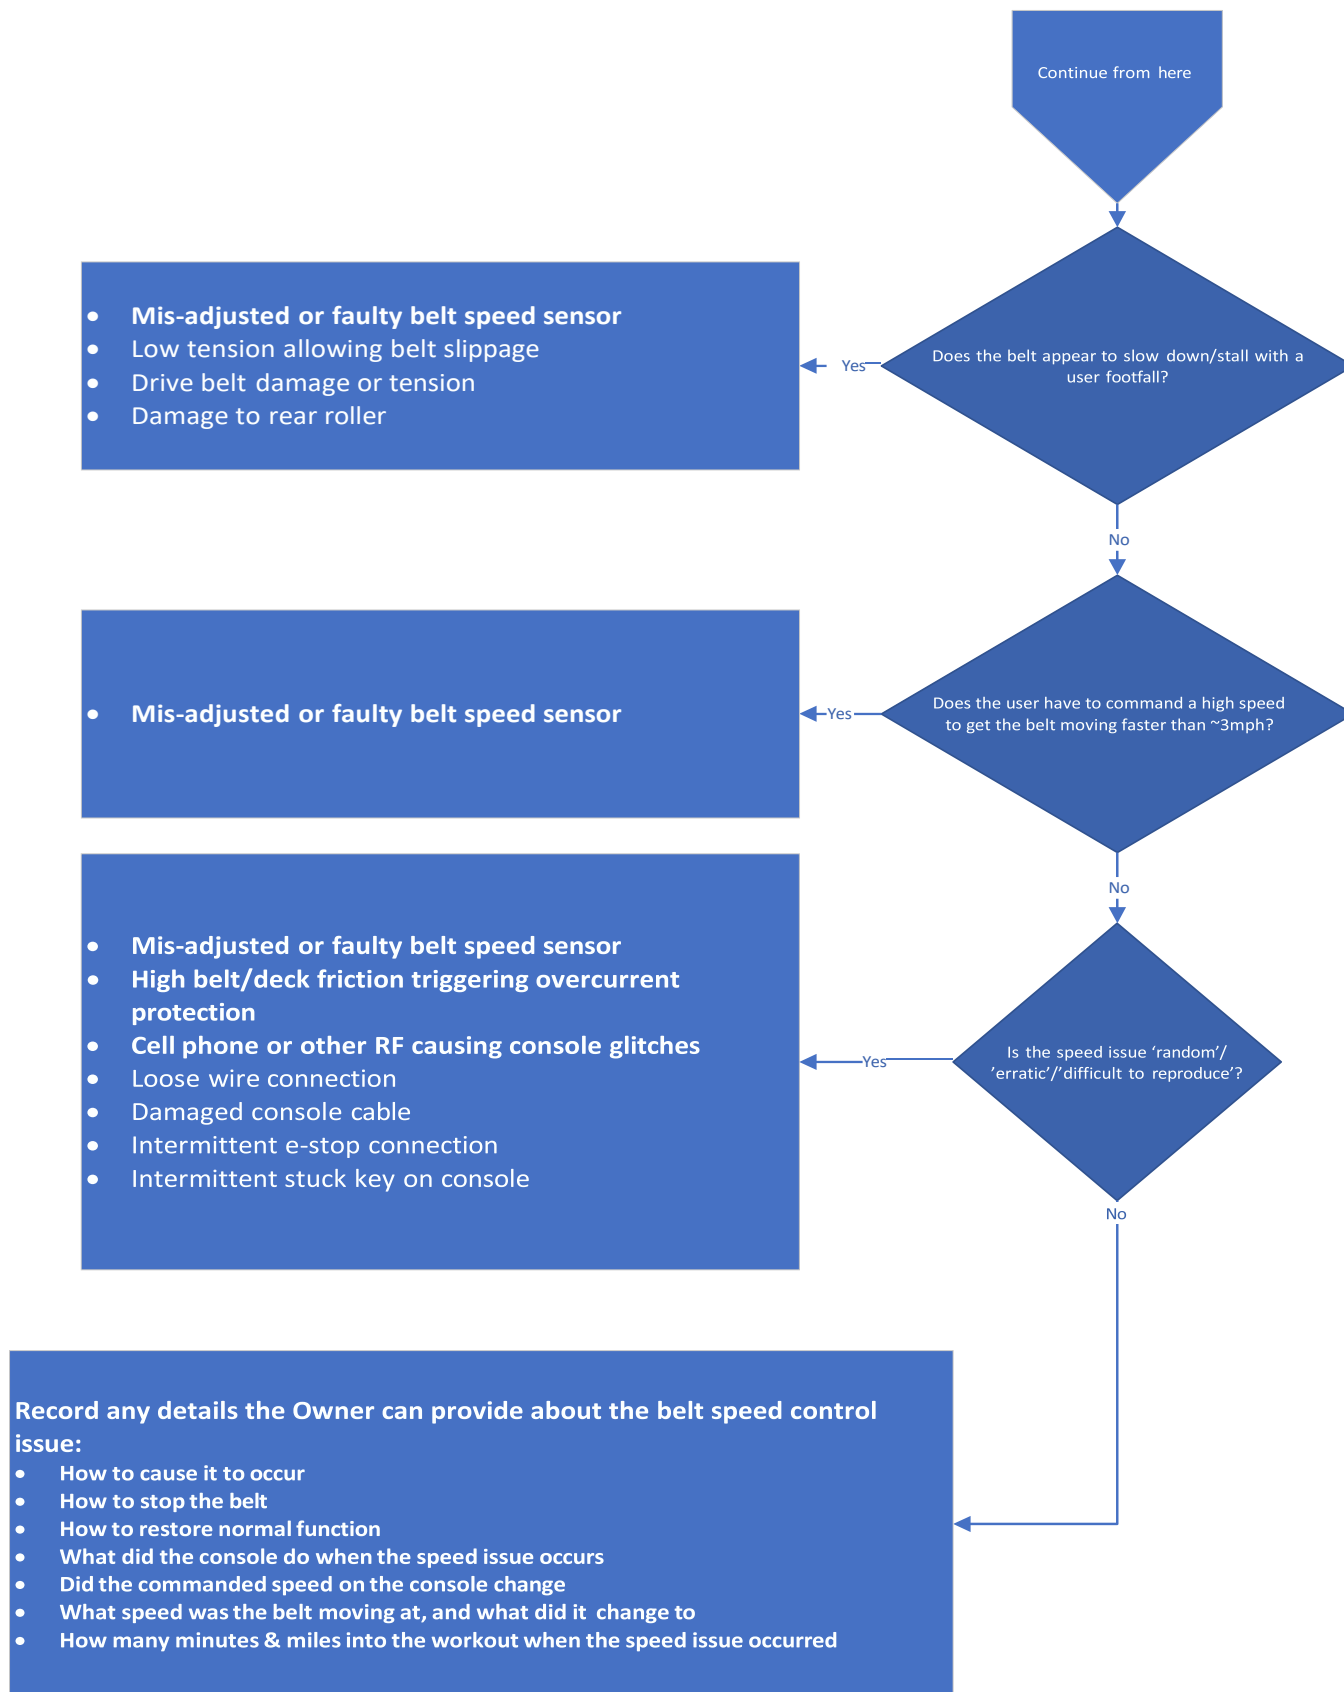
## Flowchart

With these factors ruled out, use the following flowchart to narrow down the possible root causes of the belt speed control issue.

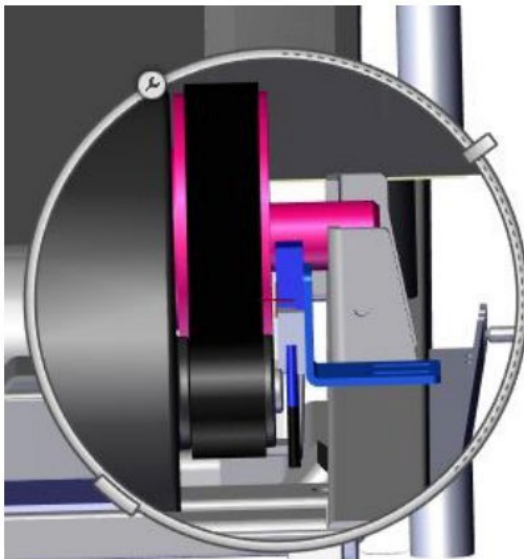
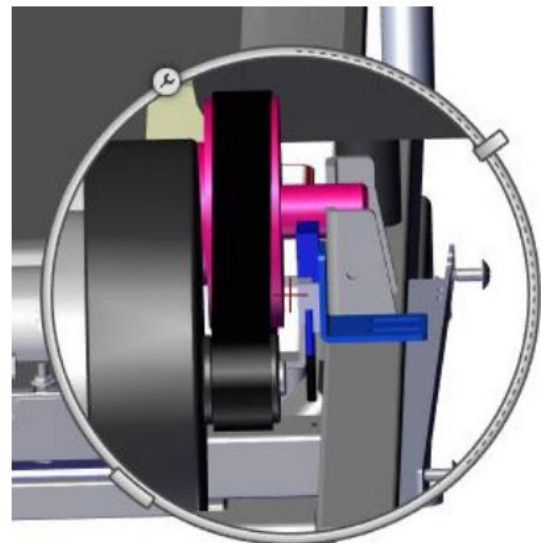
1. Disconnect power and remove the motor cover. Inspect the speed sensor, located adjacent to the front roller on the operator's left side. There should be approx. 5mm/0.2" gap between the sensor face and magnet on the front roller/pulley. The magnet on the roller should pass as near as possible to the center of the sensor. Adjust the sensor as necessary to meet this spec.

This bracket is too close to the speed sensor:

This sensor is an adequate distance from the front roller:

The position of the magnetic speed sensor is extremely sensitive on the models listed above. Being too close or too far away from the magnet on the front roller can cause several possible indications:

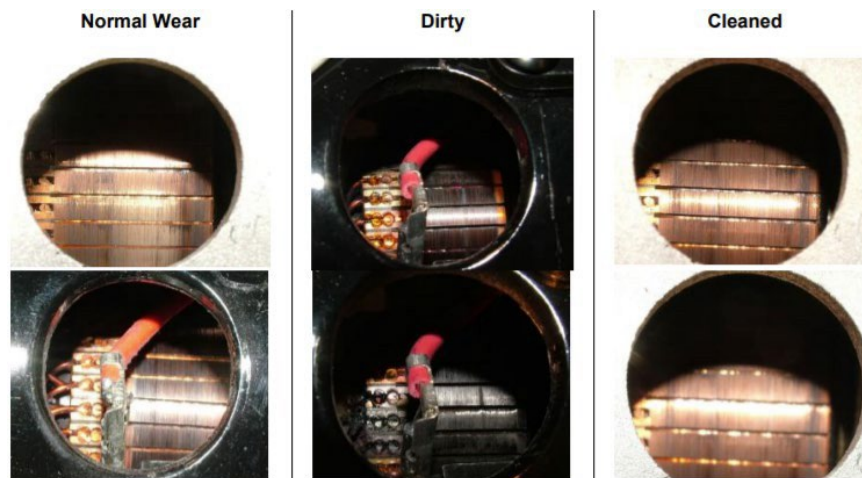
1. Disconnect power and remove the motor cover, if not already done.
2. Inspect & clean the commutator:
  - a. Remove the round plastic cap from the motor. If the commutator is copper-colored and shiny with only minor residue from the brushes, it is in good condition. If the commutator is dirty, black, or has noticeable scratches/pitting, it may need to be stoned/cleaned to remove residue.
  - b. If a commutator stone is available, insert it into the round hole perpendicularly to the commutator and apply firm pressure. Spin the motor flywheel by hand 3-5 times to remove carbon deposits from the commutator.
  - c. Use compressed air to blow any residue from inside the motor.
  - d. Replace the cap, reapply power and run the treadmill at 3 MPH for 15 minutes.
  - e. Repeat points a.-e. here until the commutator appears clean & shiny or a normal wear pattern appears.
