| Rev. A | <b>LIVESTRONG</b> | Control Number<br>XXXXXXXXXXXX |
| Effective Date<br>11/23/2009 | Out of Box: Misaligned Arm | Page<br>1/1 |

## DESCRIPTION

Follow these instructions to fix a pedal arm that is out of alignment when the Livestrong elliptical is taken out of the box. Adjust the bolt at the pivot block / pedal arm connection.

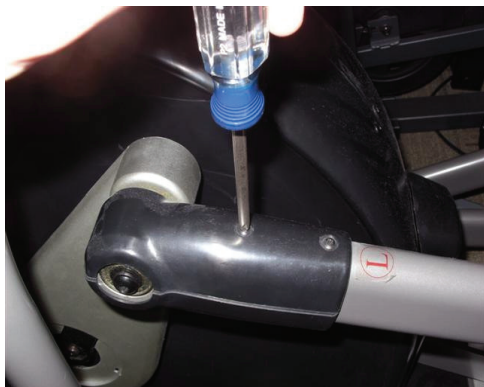
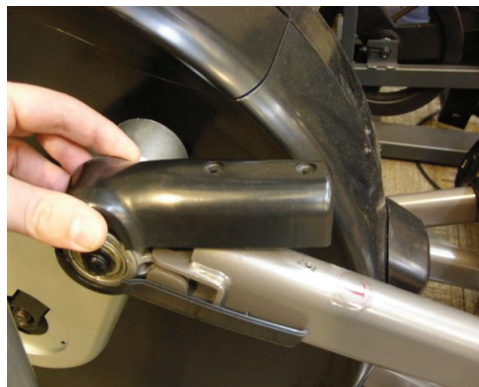
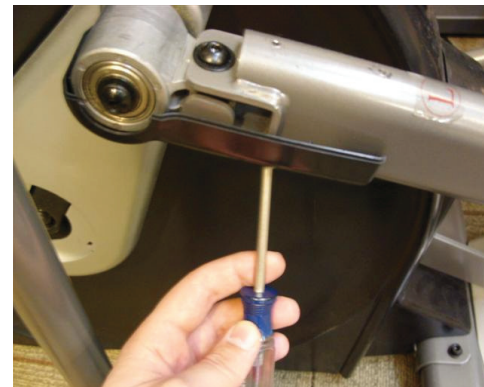
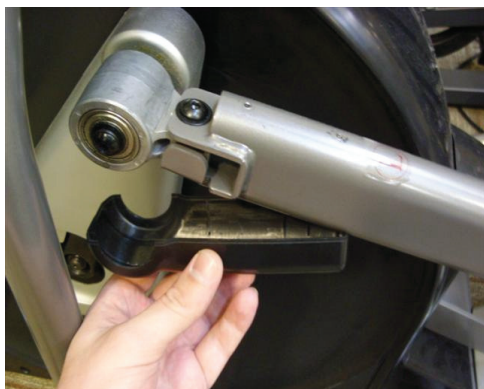
- 1) Use a Phillips screwdriver to remove the upper and lower pivot block covers (Figures A-D).
- 2) Loosen the bolt / nut revealed by removing the pivot block cover (Figure E).
- 3) Center the pedal arm roller so that the roller is making even contact with the roller track at all points in the roller path (Figure F).
- 4) Hand tighten the bolt / nut at the pivot block / pedal arm connection. **DO NOT** overtighten this bolt / nut.
- 5) Re-install the pivot block covers.
- 6) Repeat this procedure for the other side of the elliptical.
